DANE COUNTY PUBLIC LAND SURVEY MONUMENT RECORD

SECTION NUMBER: 35

TOWNSHIP 6 NORTH, RANGE 10 EAST

CORNER IDENTIFICATION NUMBER 40610350020

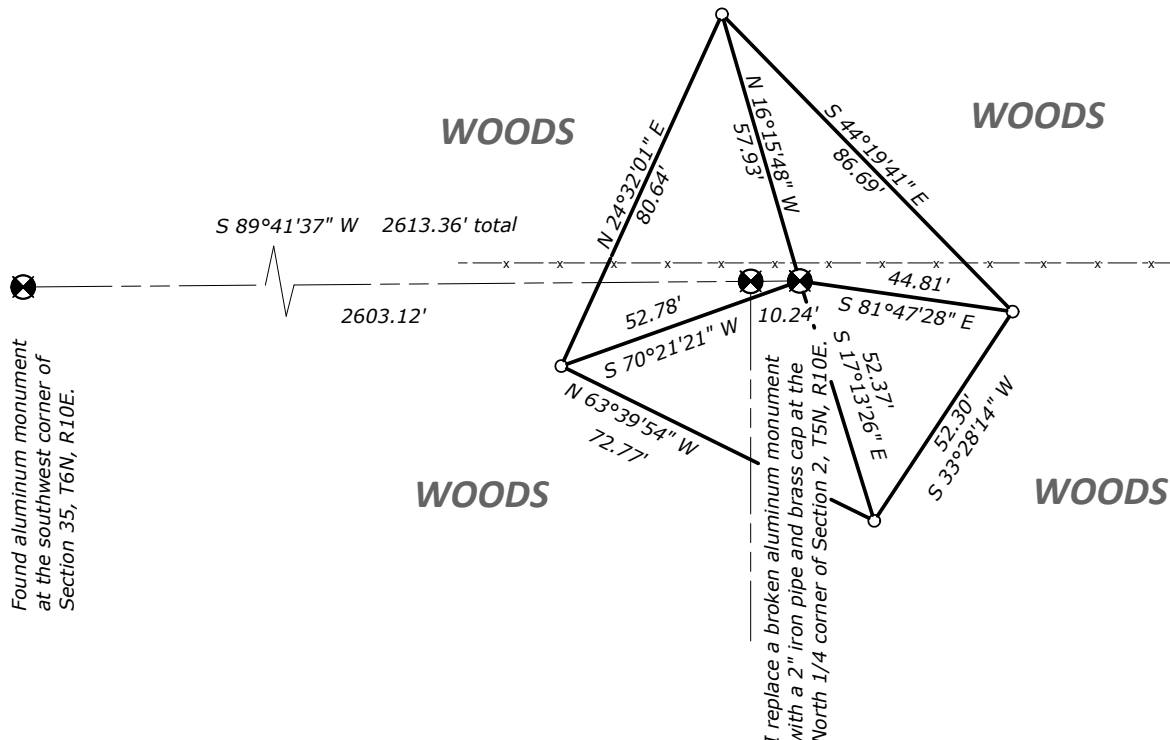
I found a Dane County aluminum monument at the corner as per Monument Record Sheet by William Karns. The aluminum monument at the north 1/4 corner of Section 2, T5N, R10E was lying in grass and had been completely removed.

I found a Dane County aluminum monument at the corner.

CLOSING CORNER
2" IRON PIPE WITH A BRASS CAP
430943.17'
849127.13'

○ Denotes set 3/4" x 24" solid round iron rod.
