Dane County Planning & Development

RE: Navigability Determination – Parcel #0507-072-8280-0, Town of Primrose

Re: Navigability determination

Location: 1350 S. Hwy JG, Town of Primrose – 0507-072-8280-0

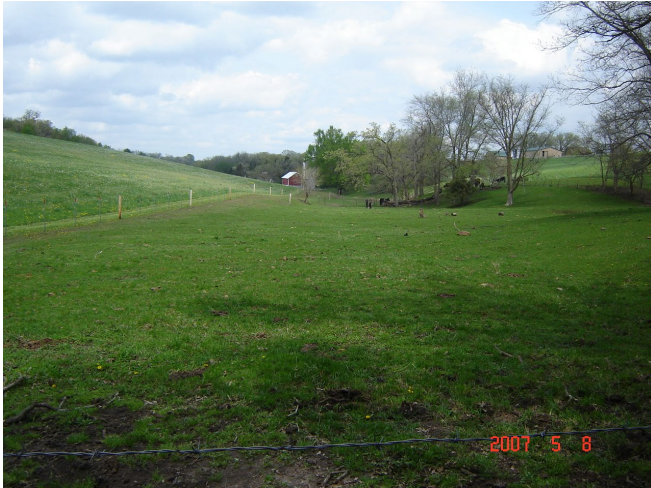
Photo 1 - Looking north towards the residence and the ag buildings.

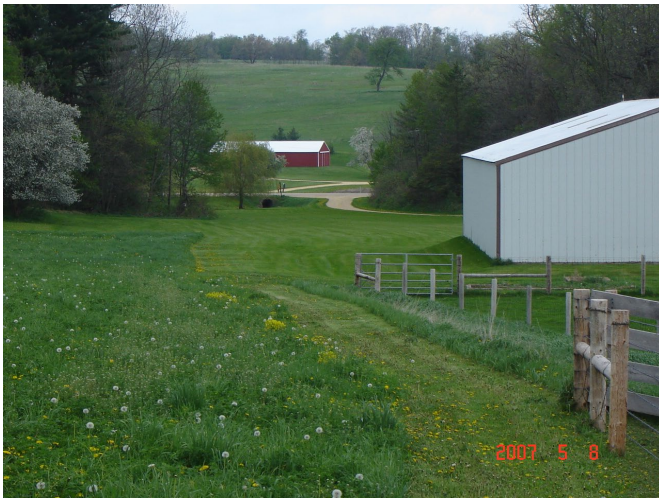
Photo 2 - Looking north towards Hwy JG.

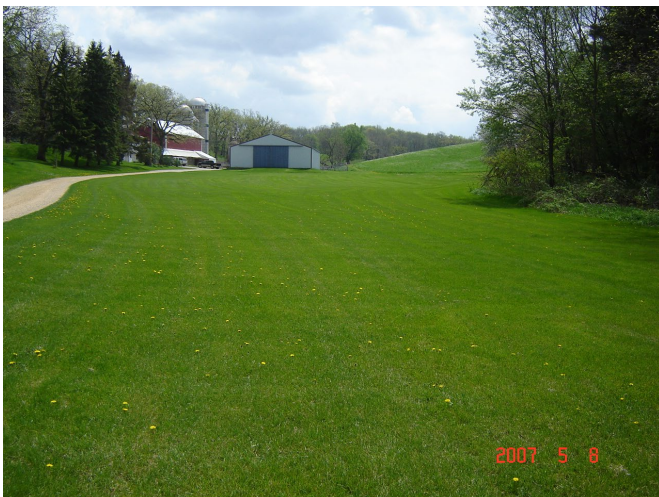
Photo 3 - Looking south from Hwy JG

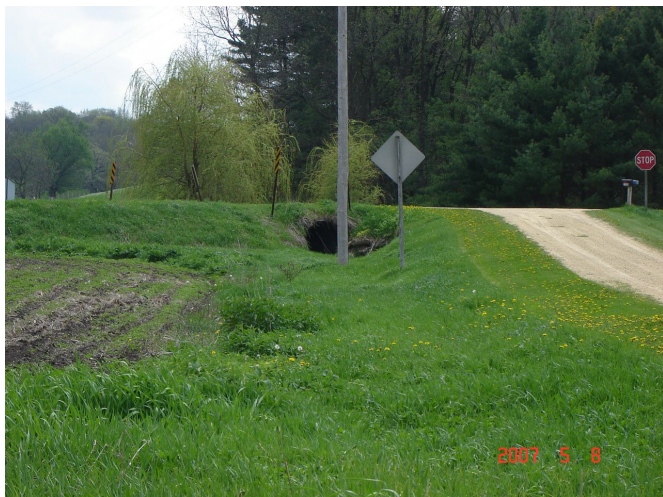
Based upon walking north and south on the property there is not a clear definitive bed and bank. However, west of the driveway accessing the subject property, there is a metal culvert pipe that leads to a navigable stream farther to the north. See attached photos.

Photo 4 - taken on the north side of Hwy JG looking south.
This is the metal culvert I was referring to in my report.

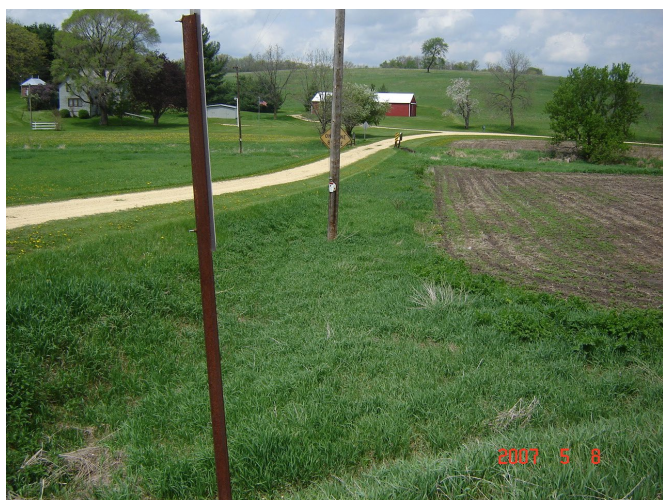
Photo 5 - taken from Hwy JG (on top of culvert) looking north.

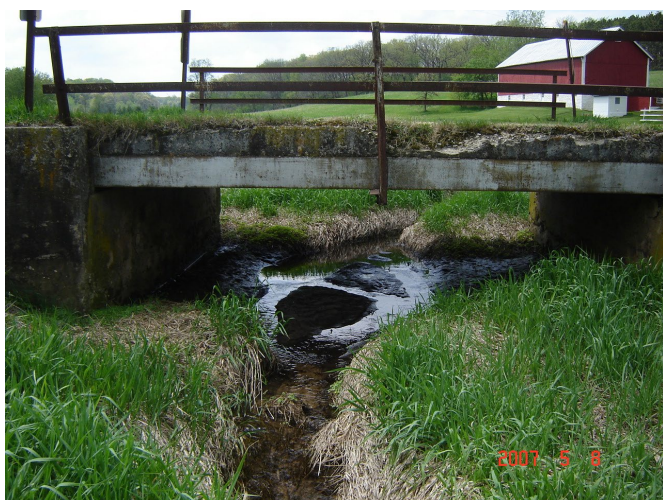
Photo 6 - Navigable stream north of Hwy JG
