# Dane County Planning & Development

RE: Navigability Determination – Town of Vienna, Section 23 and 26 - Drainage District #29 (various parcel numbers)

**Navigability Determination – Town of Vienna, Section 23 and 26**  
April 12, 2010

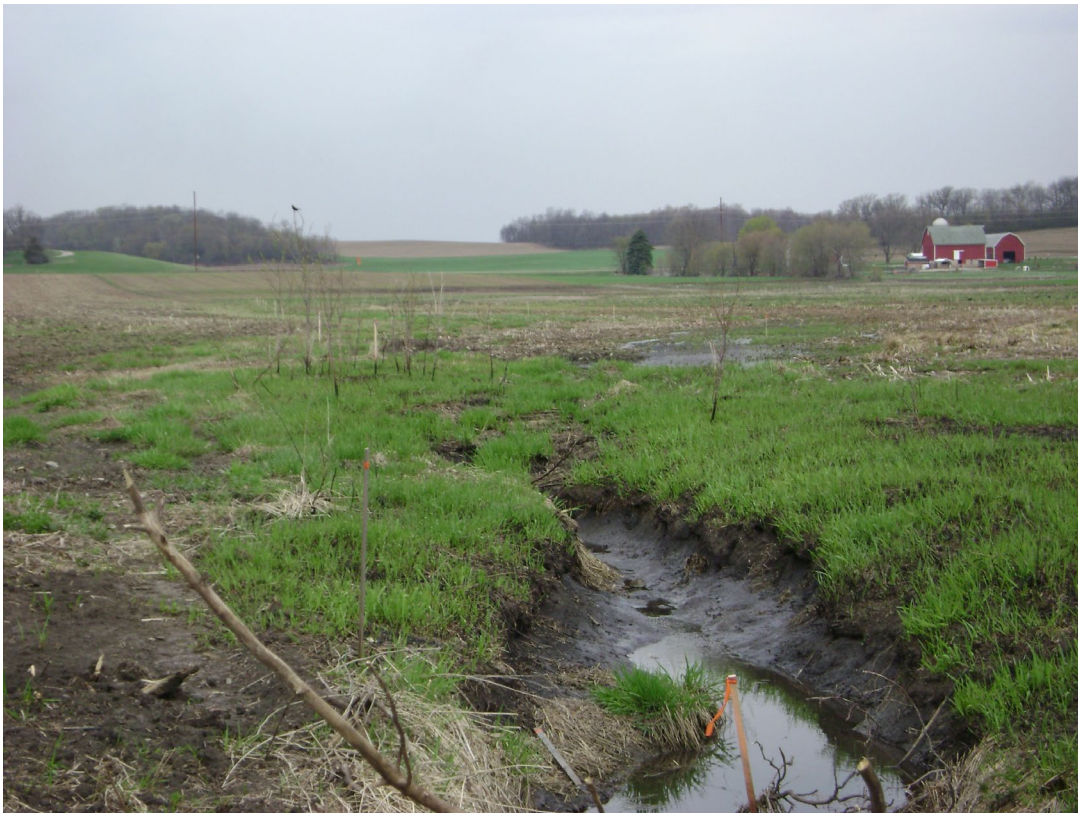
A site inspection was conducted on April 12, 2010 to verify the navigability of the waterway. It has been determined that this intermittent stream is NOT navigable until a point which is referenced as Station 27+00 on the plan view map you provided.

PHOTO 11 – Looking west. From this point (Sta 27+00) and to the north is NOT navigable. From this point to the south IS navigable.

This letter serves as notice that the ditch work that will occur on the lands described, specifically from station 27+00 and to the north **is outside the Shoreland Zoning District** as defined under section 11.02, Dane County Code of Ordinances.
