# **Assured Wetland Delineation Report**

# **496 Koch Drive**

Village of Marshall and Town of Medina, Dane County, Wisconsin July 13, 2022

Project Number: 20220771

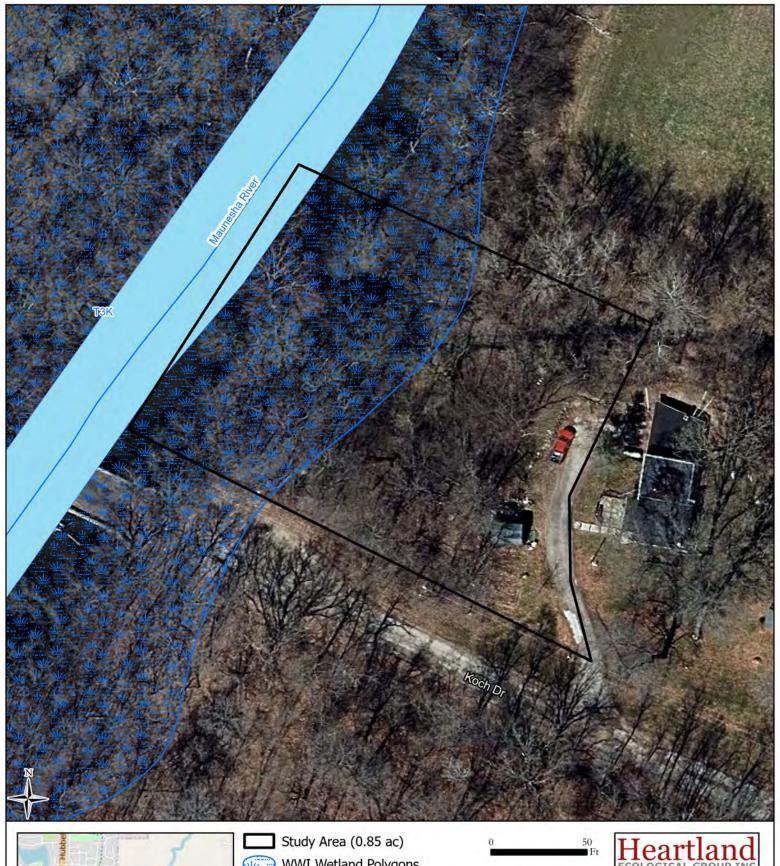
Figure 5. Wisconsin Wetland Inventory

The Wisconsin Wetlands Inventory (WWI) mapping (Figure 5, Appendix A) depicts one (1) wetland area within the Study Area. One (1) broad-leaved deciduous forested wetland (T3K) is mapped within the western half of the Study Area adjacent to the Maunesha River.

The National Hydrography Dataset 24k (NHD) mapping (Figure 5, Appendix A) depicts one (1) waterway within the Study Area. The waterway (Maunesha River) is mapped along the western boundary of the Study Area.
