Wetland Delineation Report

Krueger Property

Town of Perry, Dane County, Wisconsin

June 21, 2021

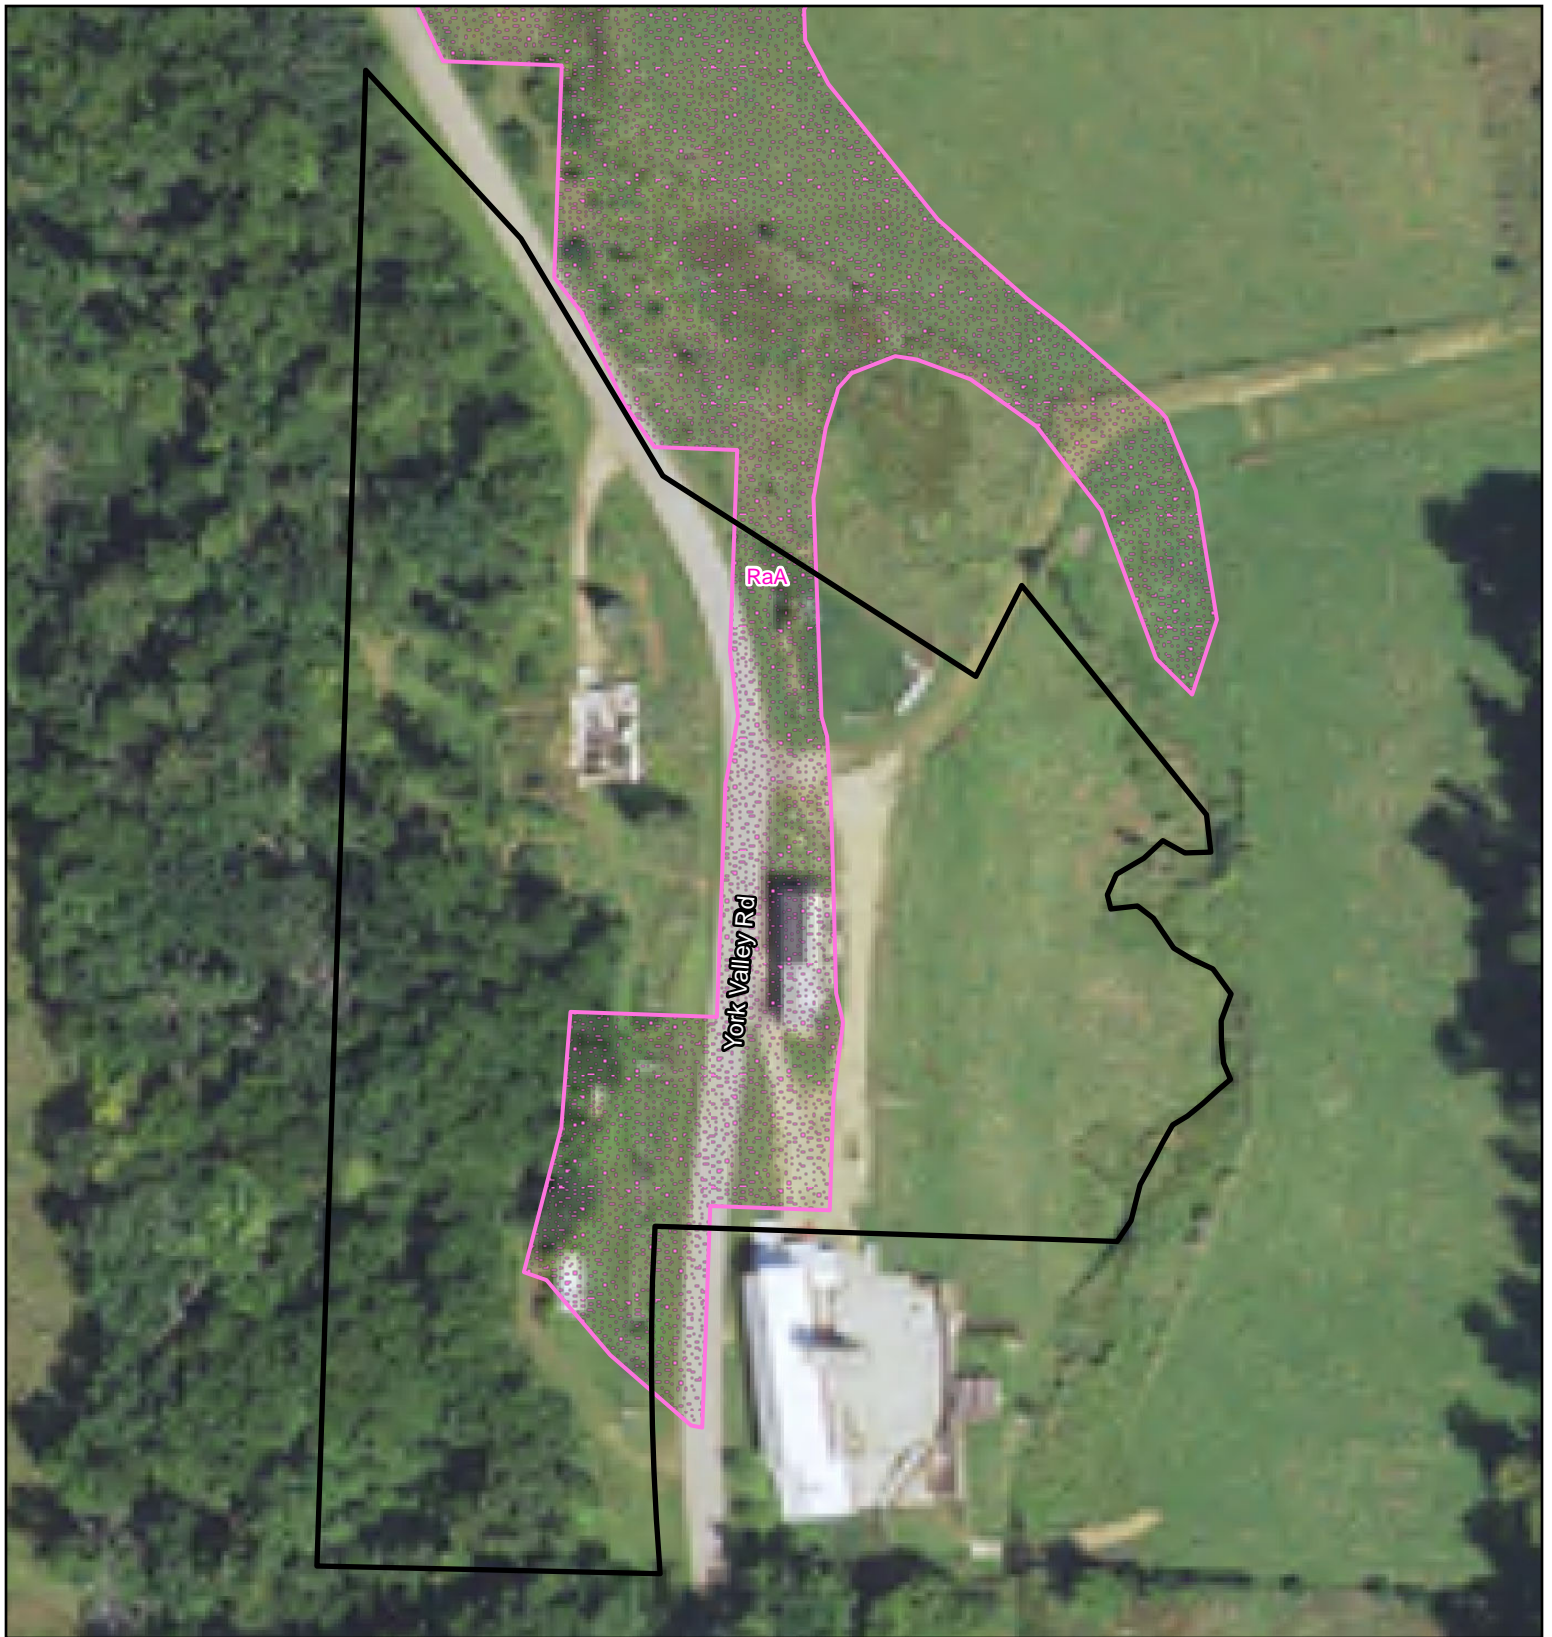
- Study Area (4.64 ac)
- Maximum Extent Wetland Indicators

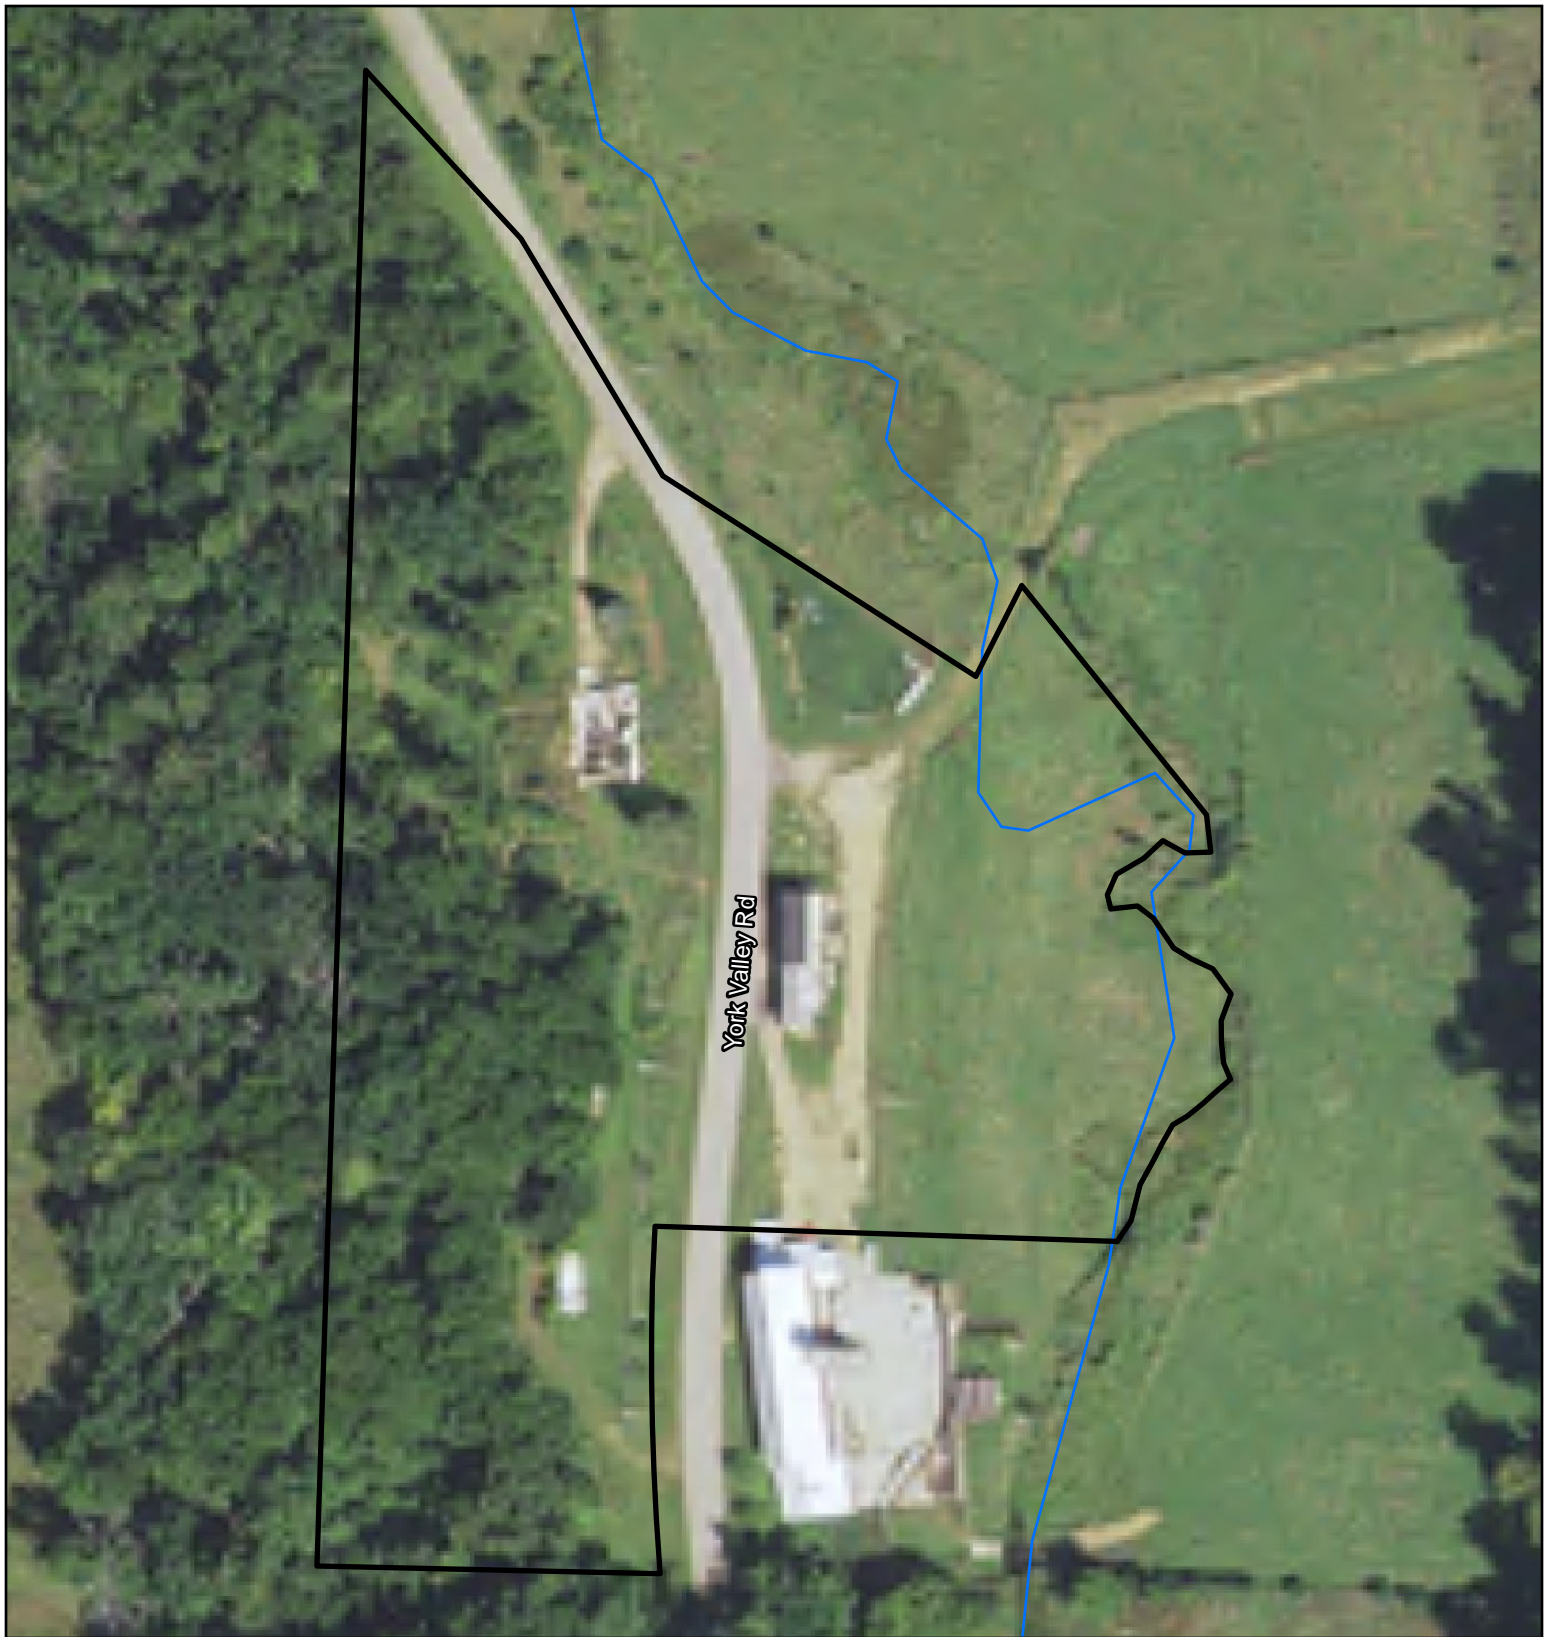
The Wisconsin Wetlands Inventory (WWI) mapping (Figure 5, Appendix A) does not depict any wetlands within the Study Area. The NHD depicts the unnamed tributary of Kittleson Valley Creek along the eastern boundary of the Study Area.

- Study Area (4.64 ac)
- WWI Wetlands (No Features in Map Extent)
- ~ NHD Waterway
