Wetland Delineation Report

~ Leitner Property

Town of Pleasant Springs, Dane County
Wisconsin

November 10th, 2015

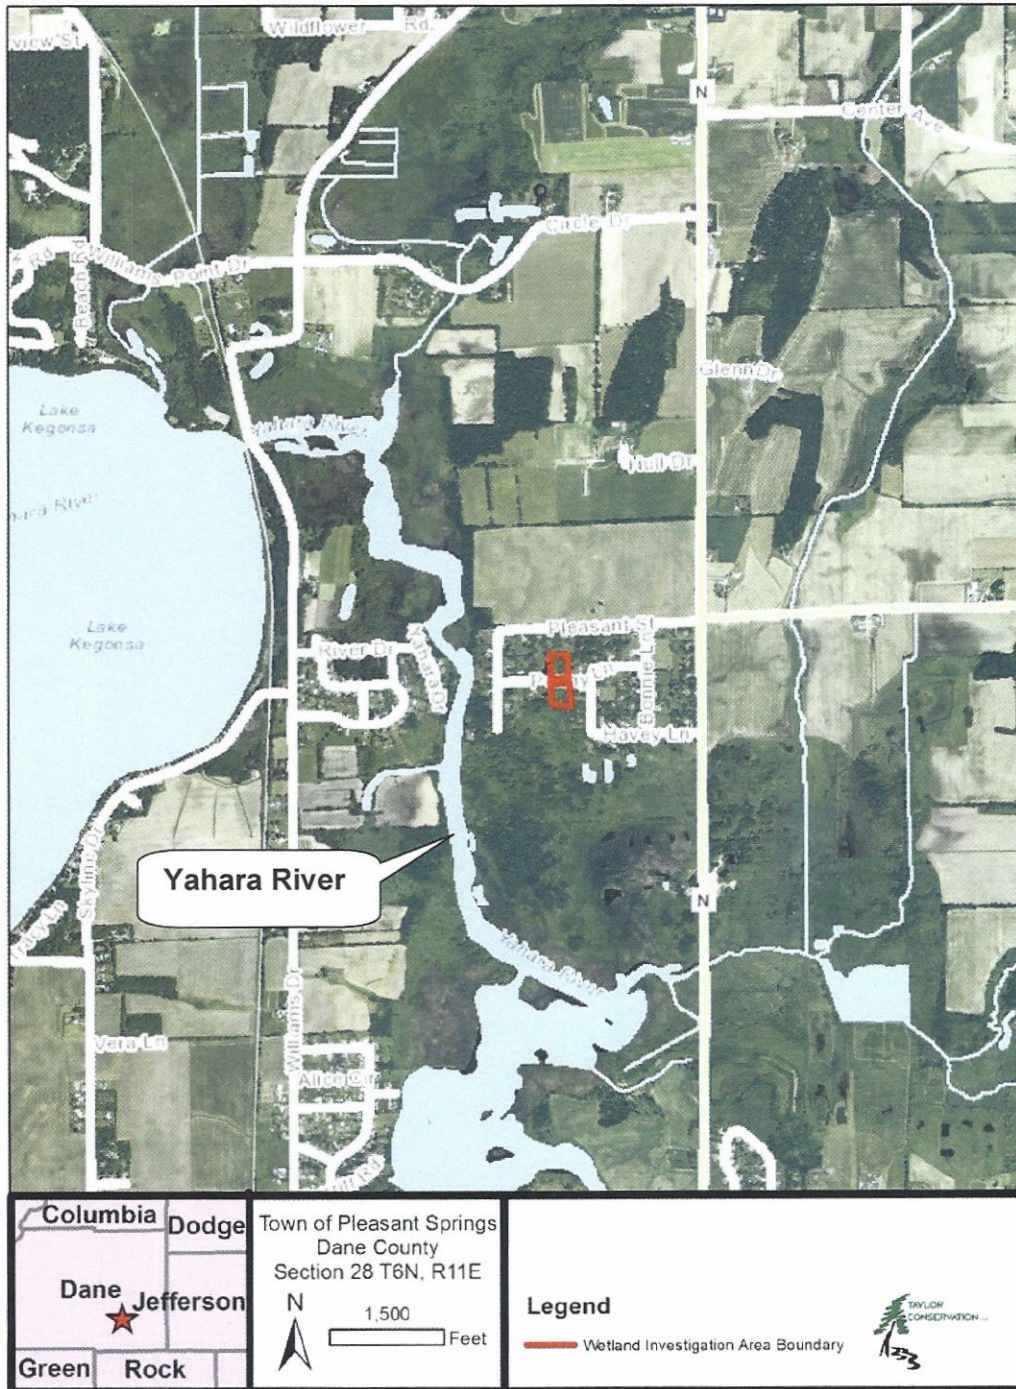
Figure 1: Landscape Overview.

Source: Imagery - National Agricultural Imagery Program, 2013; Roads & Waters – Wisconsin Department of Natural Resources.

On August 7th of 2015, Scott Taylor of Taylor Conservation, LLC performed wetland determinations and delineations on the Leitner property in the Town of Pleasant Springs, Dane County, Wisconsin (Figure 1). Two parcels were investigated (Lots 1 & 2), one on either side of Penny Lane (Figure 2). The parcels consisted of tree groves and brush. Most of the brush in Lot 2 had been cut with a forestry mower earlier in the growing season.

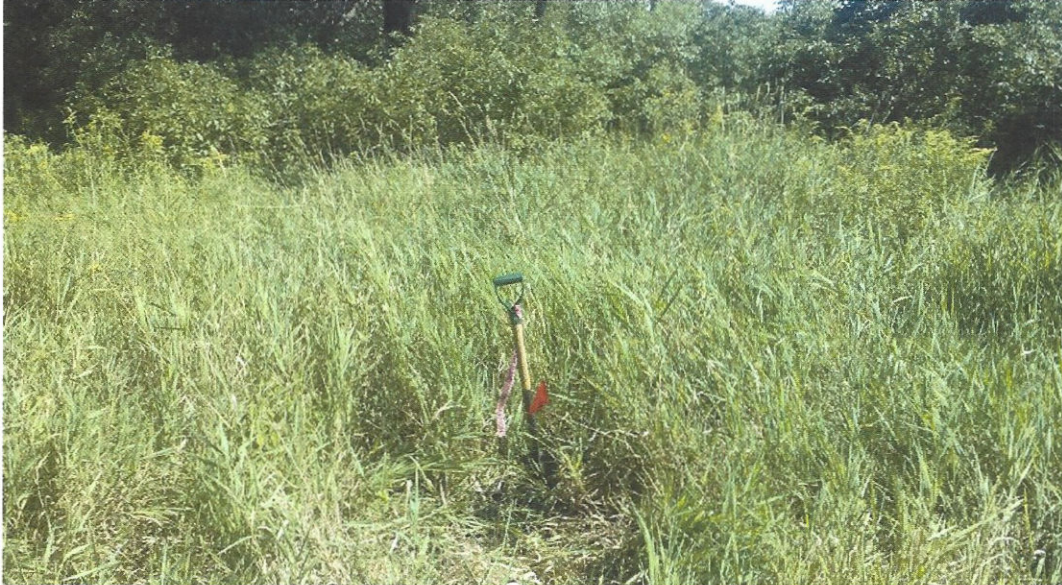
Wetland - Plot 1A

Depth (Inches)	Matrix Color (moist)	%	Color (moist)	%	Redox Features Type*	Loc**	Texture	Remarks
0-19	10 YR 2/1	100	None				Silt loam	
19-26	10 YR 4/2	98	10 YR 4/6	2	C	PL	Sandy clay loam

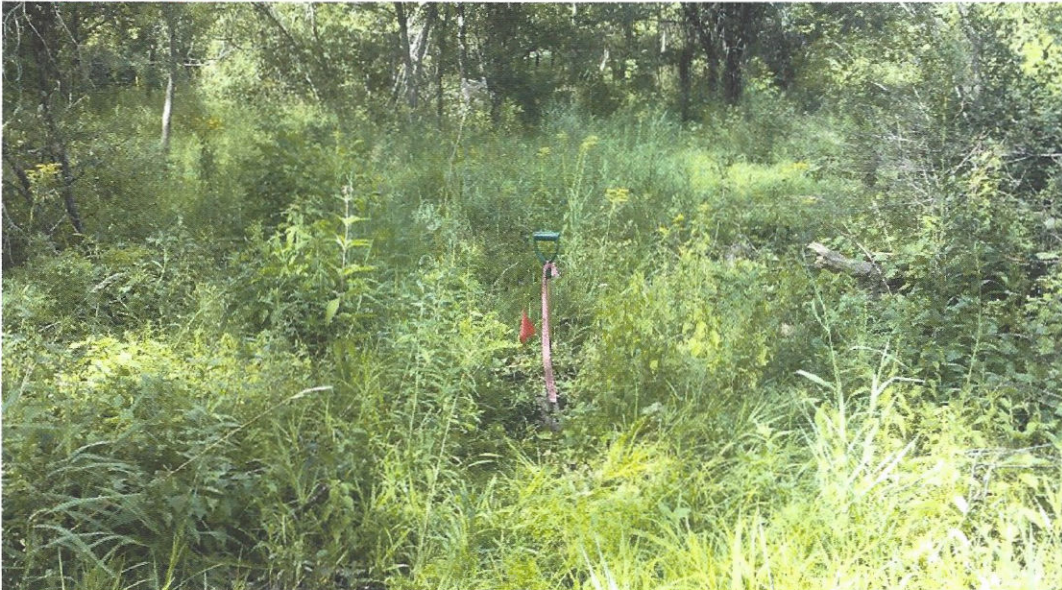
Wetland - Plot 1B

Depth (Inches)	Matrix Color (moist)	%	Color (moist)	%	Redox Features Type*	Loc**	Texture	Remarks
0-21	10 YR 2/1	100	None				Silt loam	
21-27	2.5 Y 6/2	99	10 YR 4/6	1	C	PL	Silty clay loam

The plot met the criteria of Geomorphic Position since it occupied the bottom of a depression where prolonged saturation or inundation would be likely. There were many deep tire ruts in the surrounding area, indicating wet soil conditions earlier in the growing season when the site was brush mowed.

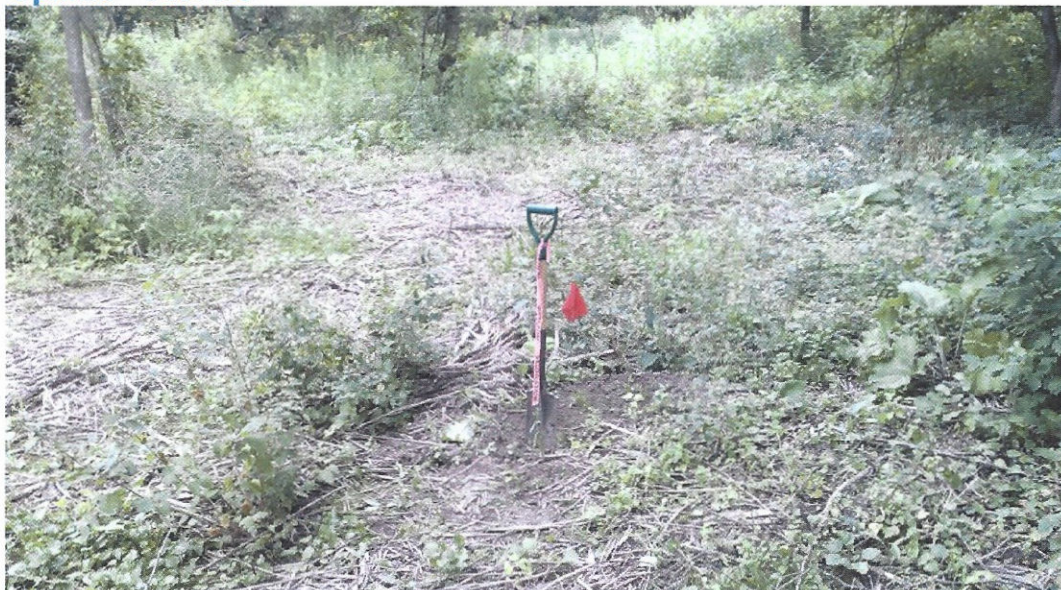
Upland - Plot 1C

Hydrophytic vegetation present? No Is the sampled area within a wetland? No
Hydric soil present? No If yes, optional wetland site ID:
Wetland hydrology present? No
Remarks: (Explain alternative procedures here or in a separate report.)
Using the Natural Resource Conservation Service weighted-month method, antecedent moisture, based on total precipitation for the previous 3 months (May-Wet; June-Normal; July-Normal; Stoughton, WI weather station), was found to be above average. No precipitation was recorded at the Stoughton weather station in the 6 days of August preceding the fieldwork. The vegetation was disturbed since the site was brush mowed earlier in the growing season. However this was not considered significant disturbance since it did not interfere with the investigator's ability to accurately identify plant species.

Depth (Inches)	Matrix Color (moist)	%	Color (moist)	%	Redox Features Type*	Loc**	Texture	Remarks
0-19	10 YR 3/2	100	None				Silt loam	
19-25	10 YR 3/2	98	10 YR 4/6	2	C	PL	Silty clay loam

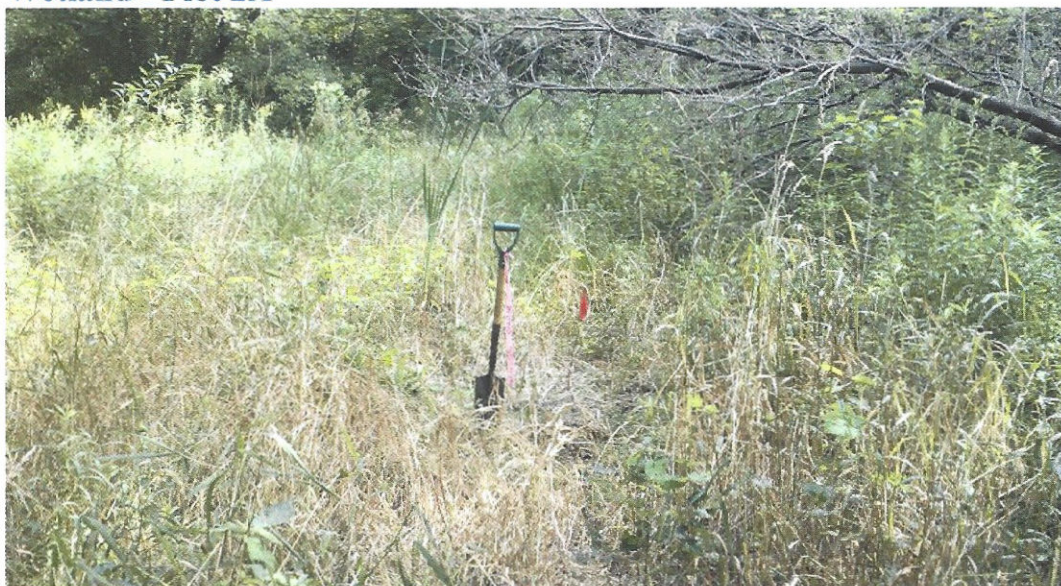
Wetland - Plot 2A

Hydrophytic vegetation present? Yes Is the sampled area within a wetland? Yes
Hydric soil present? Yes If yes, optional wetland site ID: _____
Wetland hydrology present? Yes
Remarks: (Explain alternative procedures here or in a separate report.)
Using the Natural Resource Conservation Service weighted-month method, antecedent moisture, based on total precipitation for the previous 3 months (May-Wet; June-Normal; July-Normal; Stoughton, WI weather station), was found to be above average. No precipitation was recorded at the Stoughton weather station in the 6 days of August preceding the fieldwork. The soil was naturally problematic since it was judged hydric even though no hydric indicators were observed.

Depth (Inches)	Matrix Color (moist)	%	Color (moist)	%	Redox Features Type*	Loc**	Texture	Remarks
0-3	10 YR 2/2	100	None				Silt loam	many rocks
3-13	10 YR 3/3	100	None				Silty clay loam	many rocks
13-24	10 YR 2/1	98	10 YR 4/6	2	C	PL	Silt loam	many rocks

No hydric indicators were observed however professional judgement was used to assume the soil was hydric based on vegetation and landscape position indicators. The black layer at the bottom of the profile may have been the original surface layer. The material above the bottom horizon may have been fill placed here in the distant past.

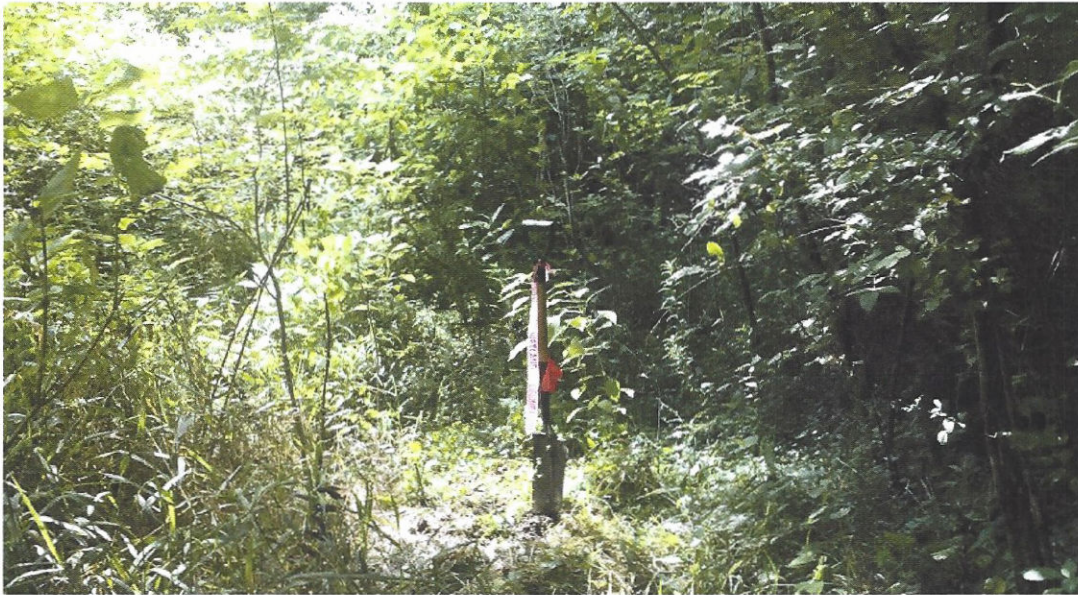
Upland - Plot 2B

The field-observed upland soils consisted of alternating layers of dark brown and brown (10 YR 3/2, 2/2, 3/3, 4/4) silt loam and silty clay loam. Irregular surface contours, suggesting placement of fill in the distant past, were noted surrounding plot 2B in Lot 1.

Hydrophytic vegetation present? No Is the sampled area within a wetland? No
Hydric soil present? No If yes, optional wetland site ID: _____
Wetland hydrology present? No
Remarks: (Explain alternative procedures here or in a separate report.)
Using the Natural Resource Conservation Service weighted-month method, antecedent moisture, based on total precipitation for the previous 3 months (May-Wet; June-Normal; July-Normal; Stoughton, WI weather station), was found to be above average. No precipitation was recorded at the Stoughton weather station in the 6 days of August preceding the fieldwork.

Depth (Inches)	Matrix Color (moist)	%	Color (moist)	%	Redox Features Type*	Loc**	Texture	Remarks
0-3	10 YR 3/2	100	None				Silt loam	
3-18	10 YR 3/3	98	10 YR 4/6	2	C	PL	Silt loam	
18-24	10 YR 3/2	98	10 YR 4/6	2	C	PL	Silt loam

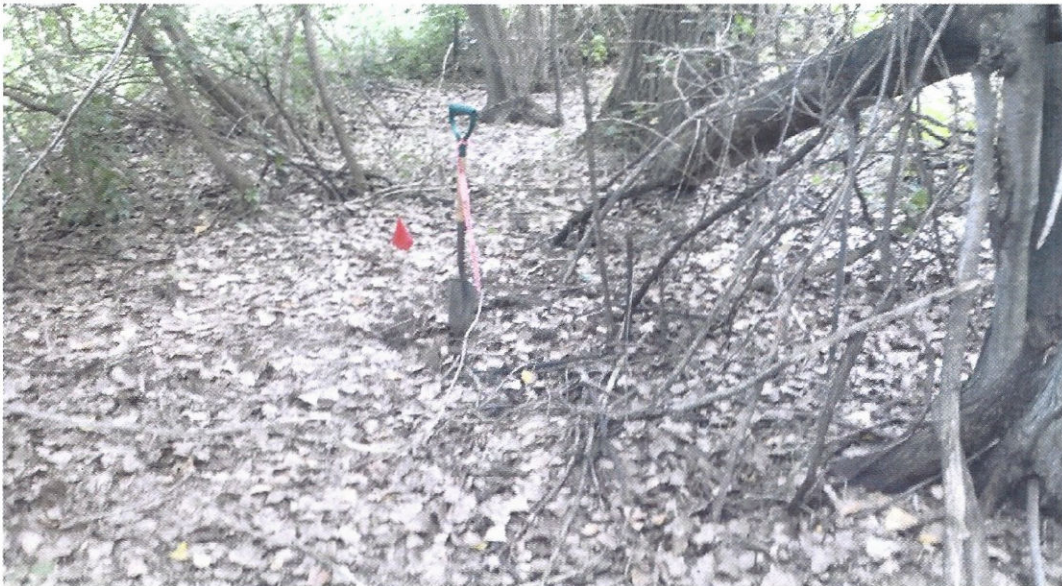
Wetland - Plot 3

Hydrophytic vegetation present? Yes Is the sampled area within a wetland? Yes
Hydric soil present? Yes If yes, optional wetland site ID: _____
Wetland hydrology present? Yes
Remarks: (Explain alternative procedures here or in a separate report.)
Using the Natural Resource Conservation Service weighted-month method, antecedent moisture, based on total precipitation for the previous 3 months (May-Wet; June-Normal; July-Normal; Stoughton, WI weather station), was found to be above average. No precipitation was recorded at the Stoughton weather station in the 6 days of August preceding the fieldwork. The soil was naturally problematic since it was judged hydric even though no hydric indicators were observed.
