Wetland Delineation Report
~
Pink Elephant Investments LLC

Town of Vienna, Dane County
Wisconsin

January 6th, 2019

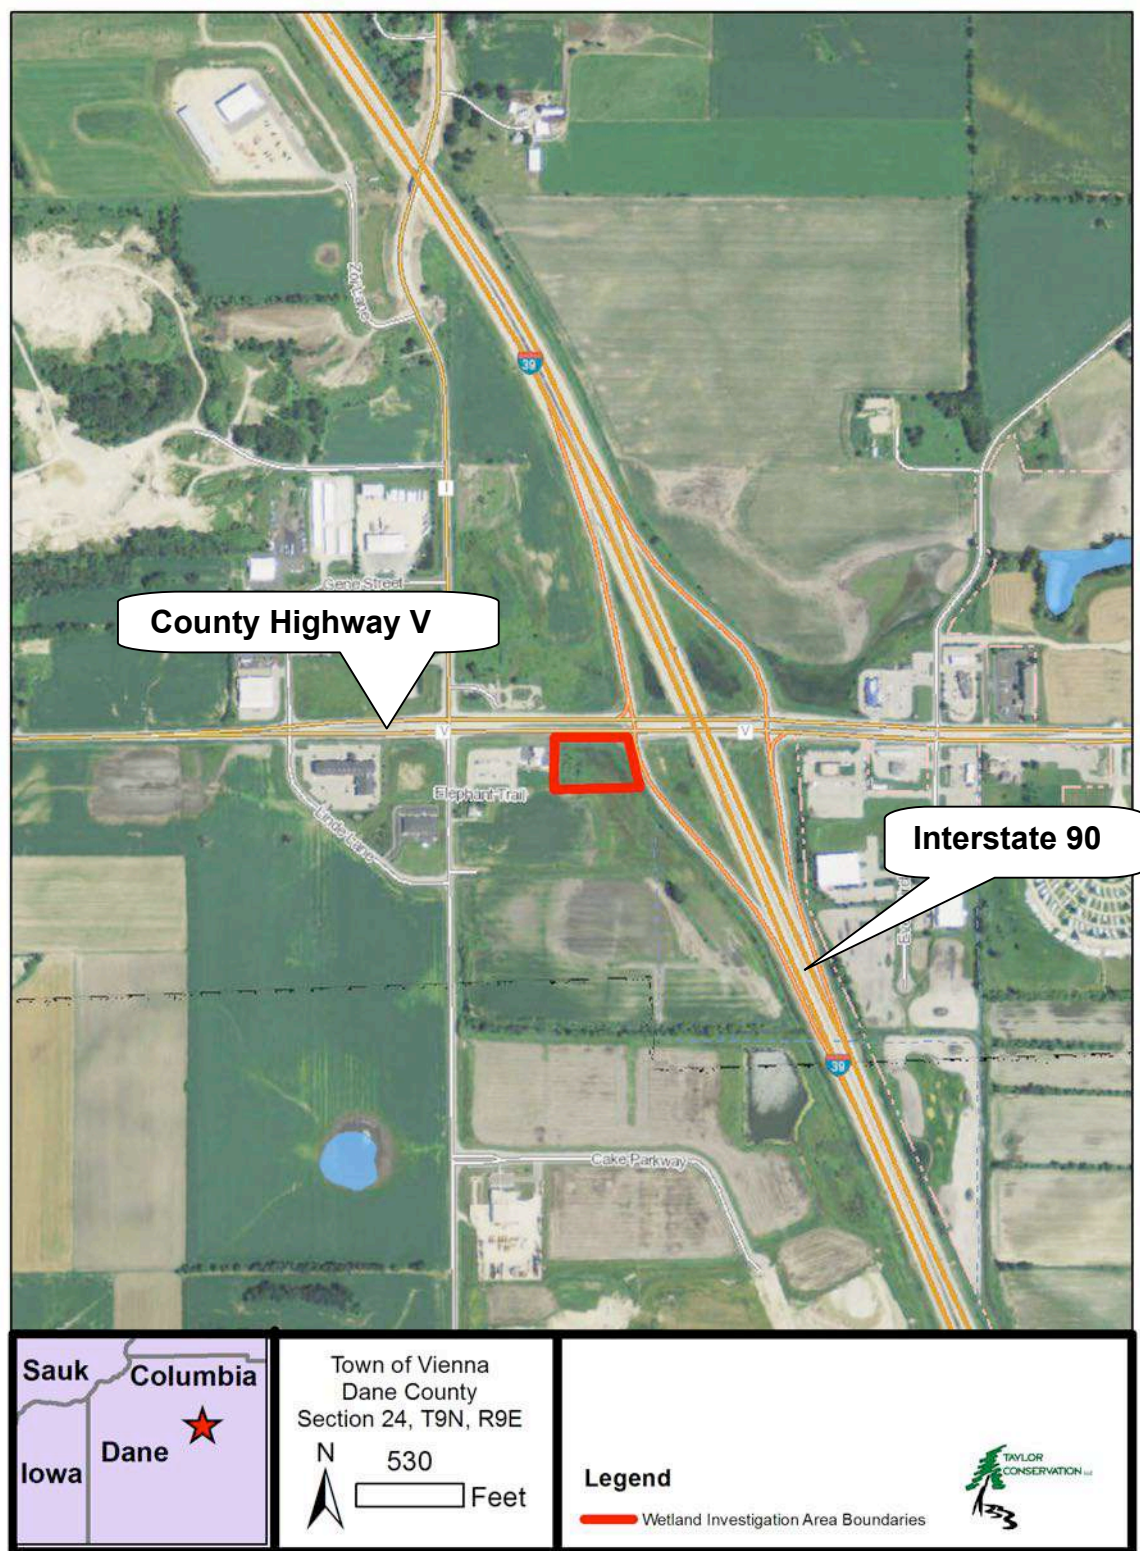
Figure 1: Landscape Overview.

Source: Imagery - National Agricultural Imagery Program, 2013; Roads & Waters – Wisconsin Department of Natural Resources.

On September 13th of 2019, Scott Taylor of Taylor Conservation, LLC performed wetland determinations and delineations on the Pink Elephant Investments LLC property in the Town of Vienna, Dane County, Wisconsin (Figures 1 & 2).

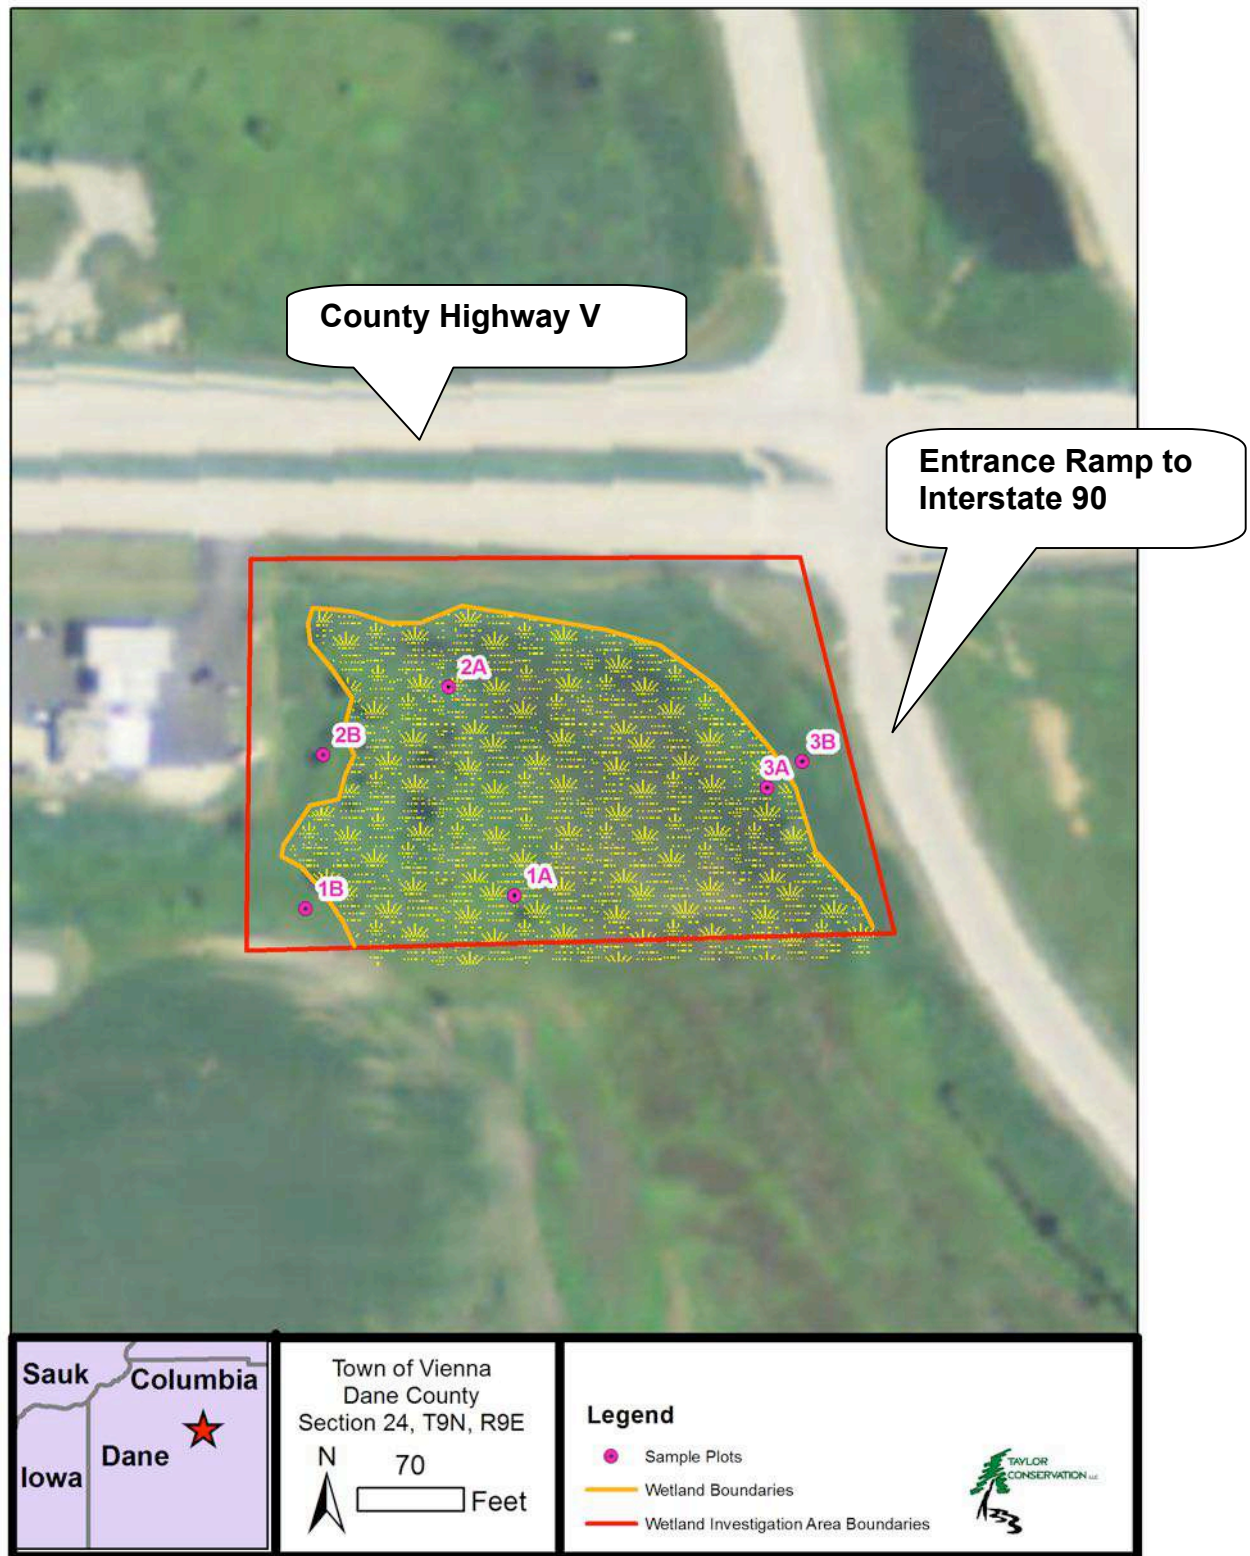
Figure 2: Investigation Area, Wetlands & Sample Plots.

hImagery Source: National Agricultural Imagery Program, 2013.

this plot suggested that the location was inside of the upland, no further plots were sampled. Otherwise, the process was repeated. A total of 6 plots were sampled, 3 inside of wetlands and 3 on the uplands (Figure 2).

The uplands (non-wetlands) were the grassy side slopes of the wetland basin. They were embankments leading up to road shoulders and other paved areas overlooking the wetland basin (Figure 2).

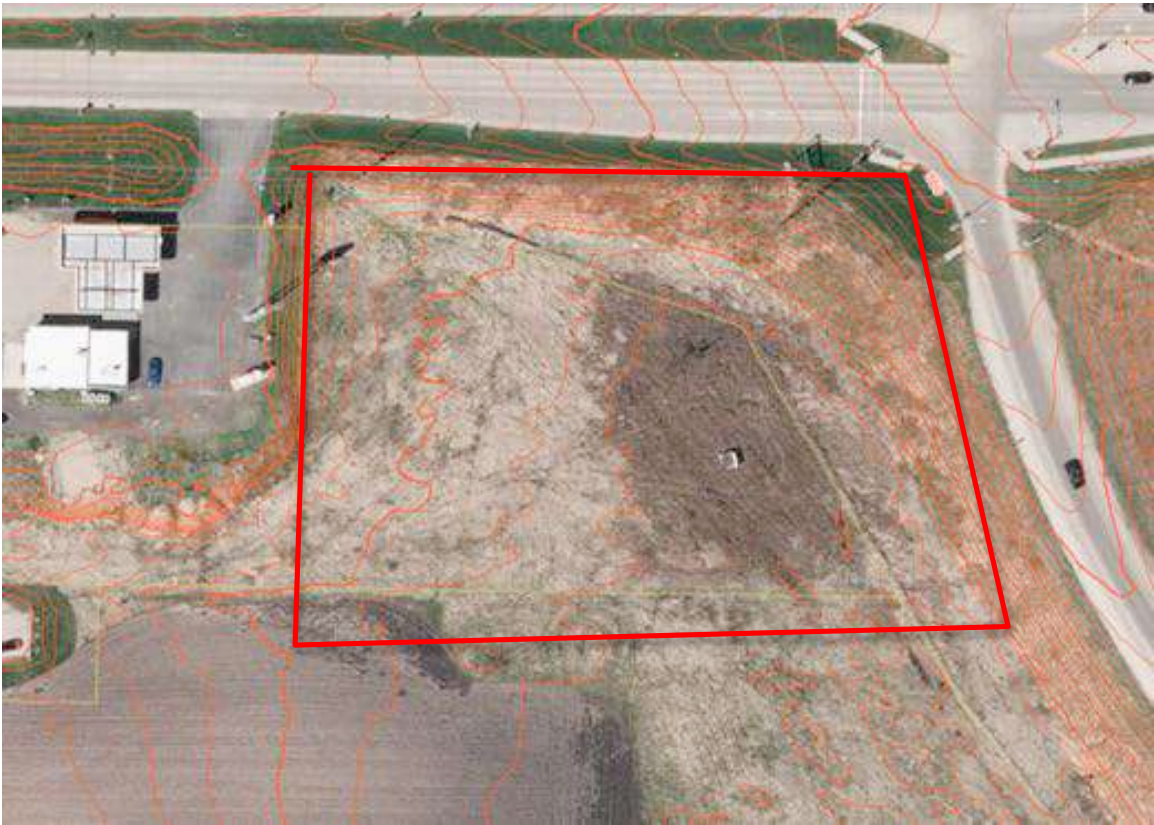
Figure 3: Topography – 2-foot Contour Map.

The 2-foot contour map shows level ground over most of the investigation area. Steep slopes surround the basin to the west, north and east (Figure 3). The United States Geological Survey Map does not identify any features in the investigation area (Figure 4).

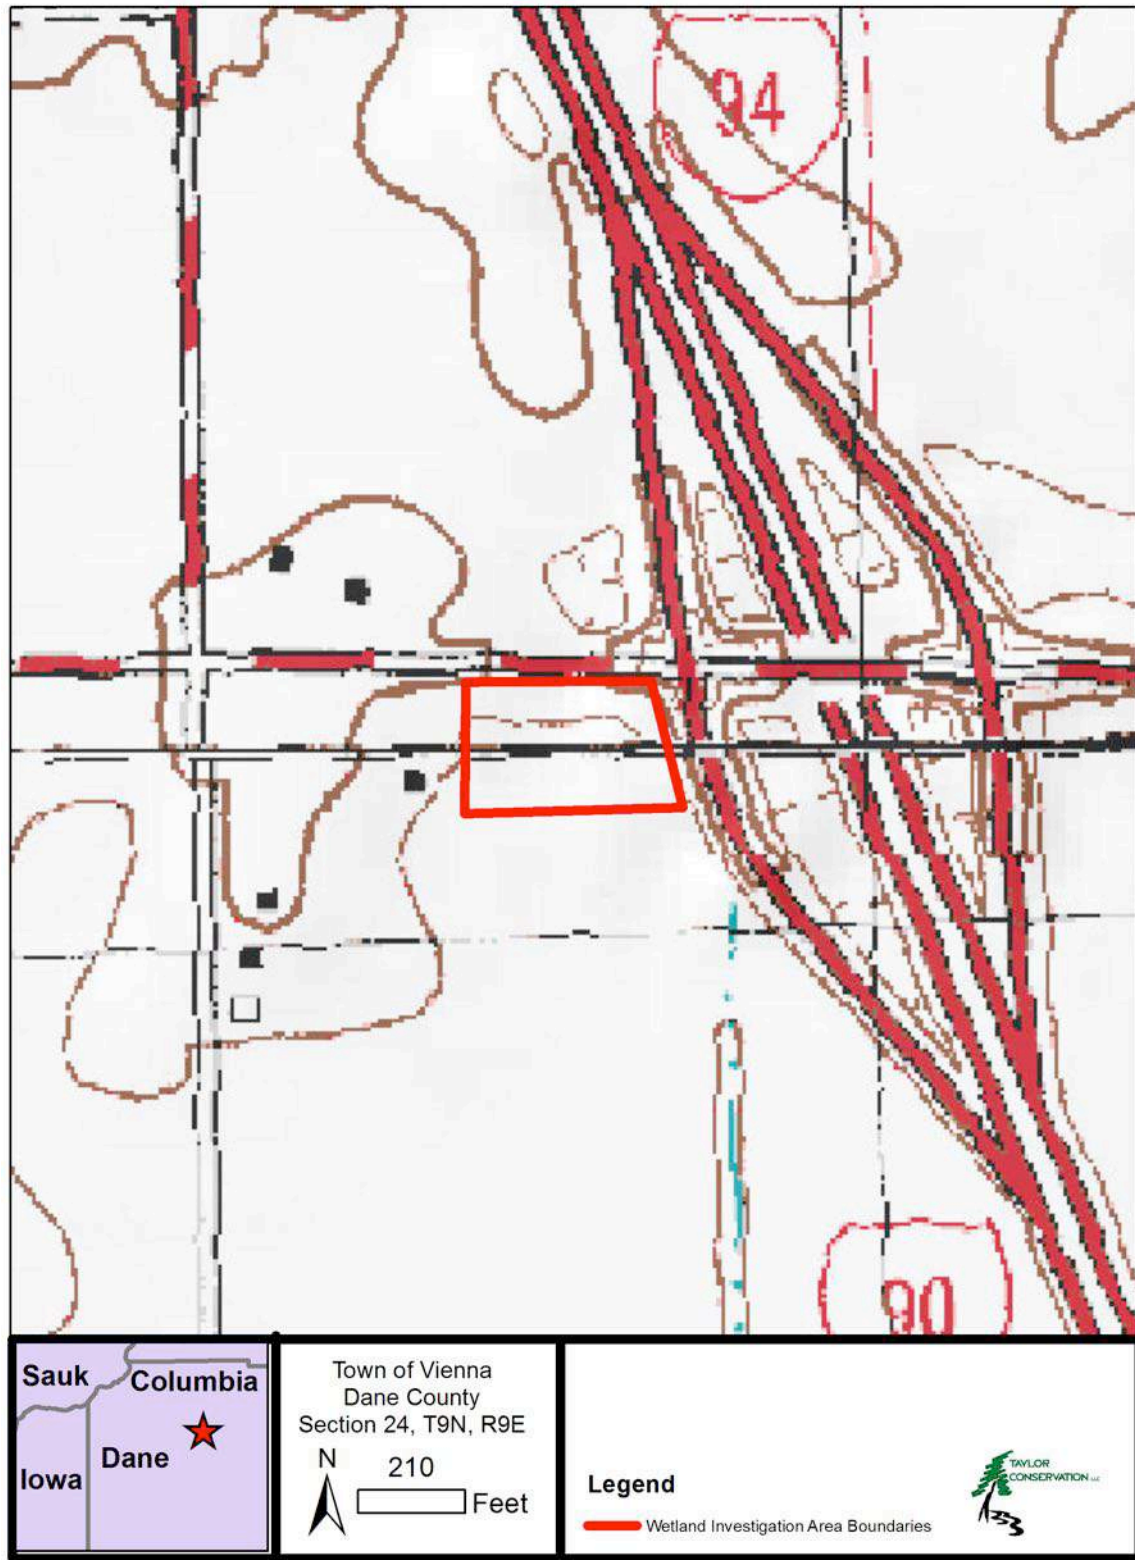
Figure 4: Topography – United States Geological Survey Map.

Source: U.S. Geological Survey 7.5-Minute Quadrangle Map, Arlington Quadrangle.

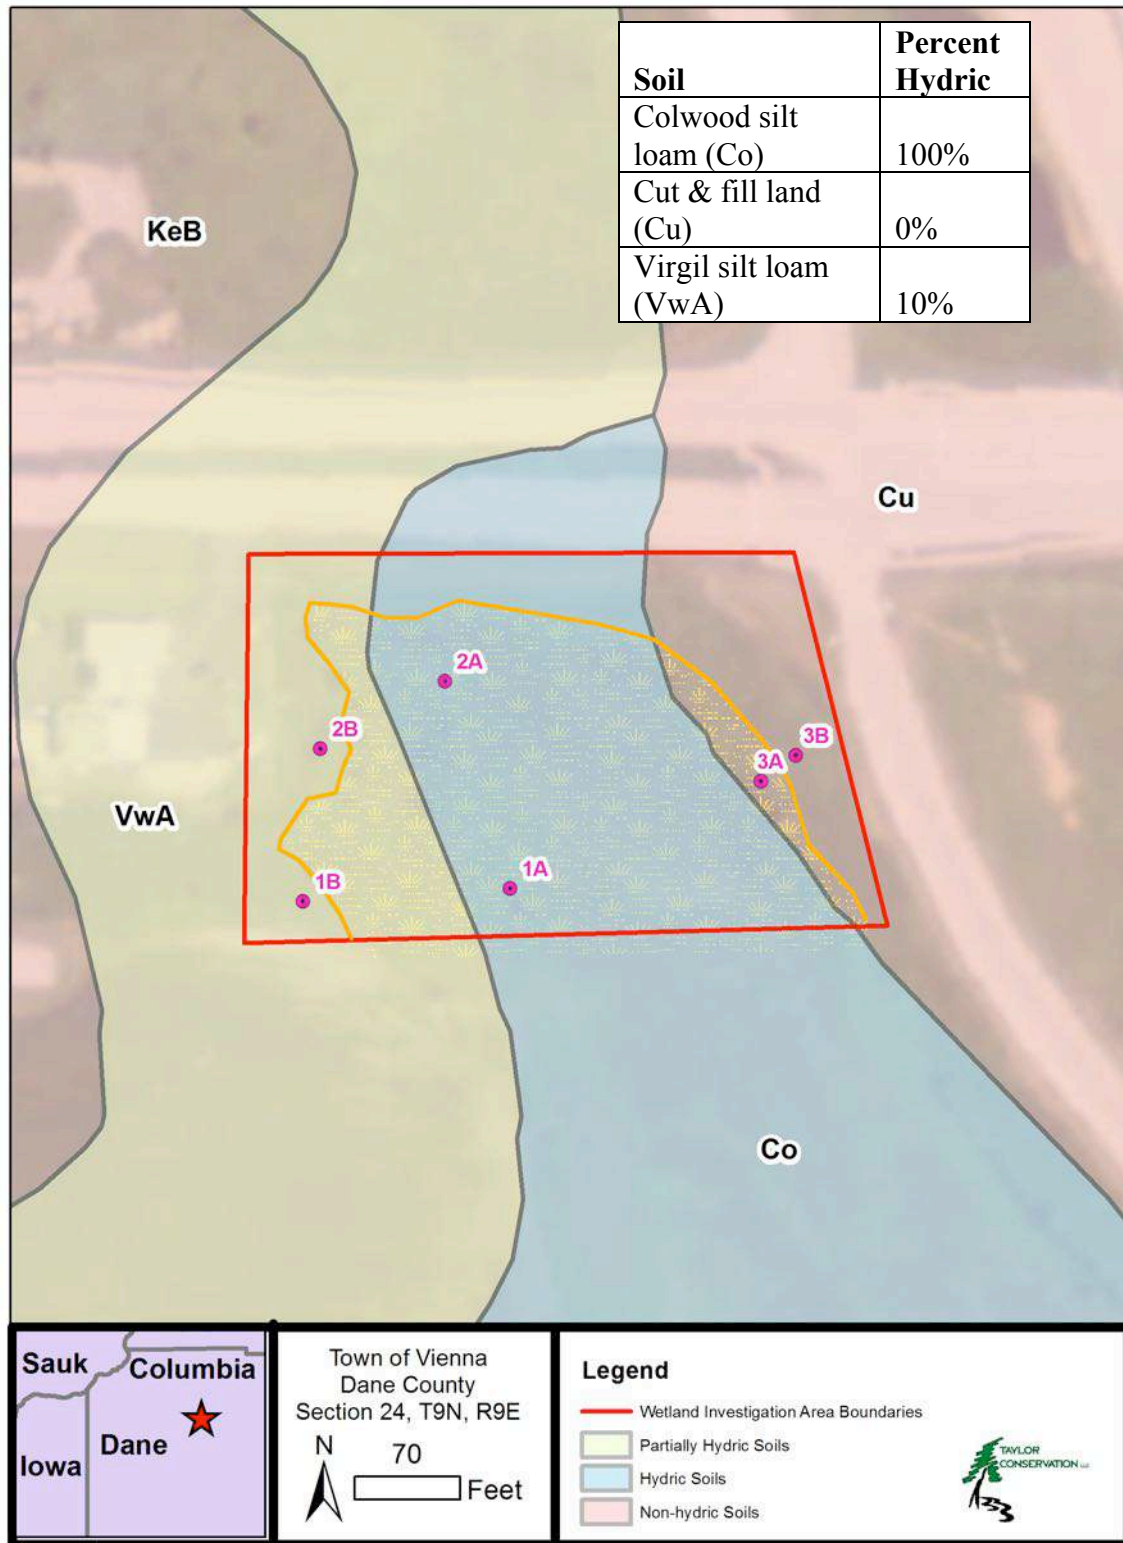
Figure 5: Soils.

The Natural Resource Conservation Service-mapped soils of the wetland investigation area are (Figure 5):

Soil	Percent Hydric
Colwood silt loam (Co)	100%
Cut & fill land (Cu)	0%
Virgil silt loam (VwA)	10%

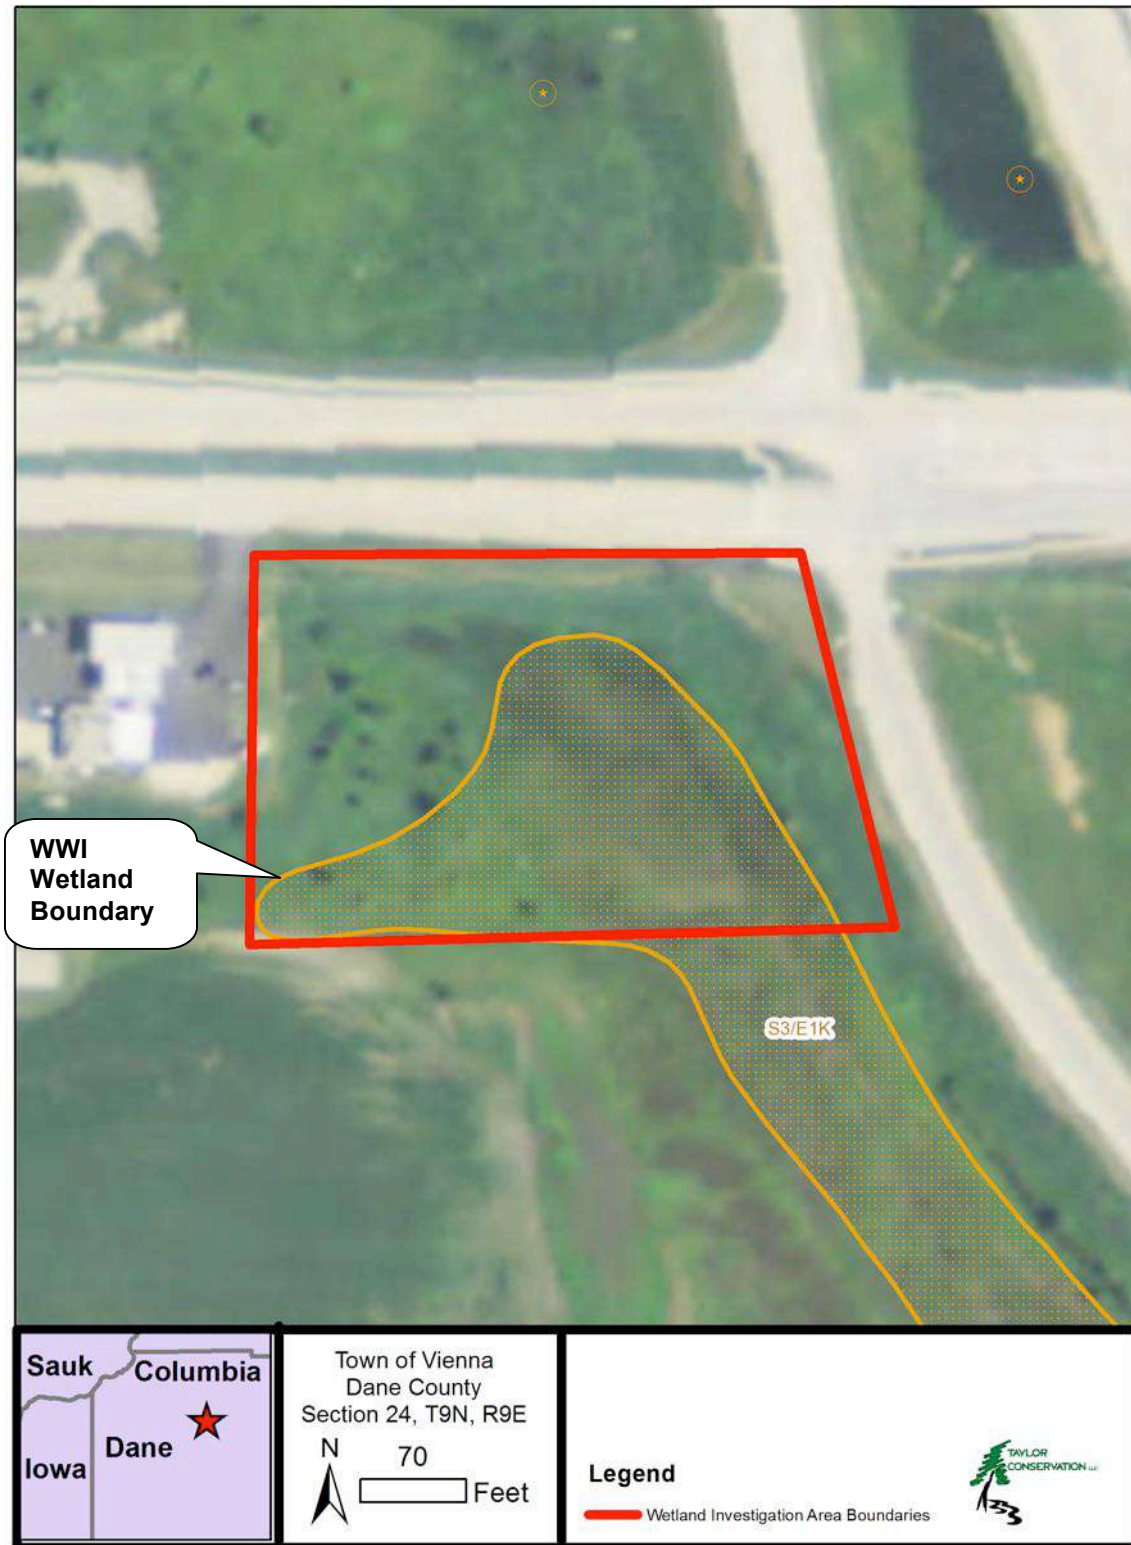
Figure 6: Wisconsin Wetland Inventory Map.

The Wisconsin Wetlands Inventory (WWI) identifies a shrub and emergent plant-dominated wetland (S3/E1K; Figure 6). Mapped wetland boundaries matched the field-identified wetland boundaries loosely. Discrepancies between the W.W.I. and field-identified wetland boundaries reflect the greater accuracy of field methods over interpretation of wetland boundaries from aerial photographs, which is the method used in the W.W.I.

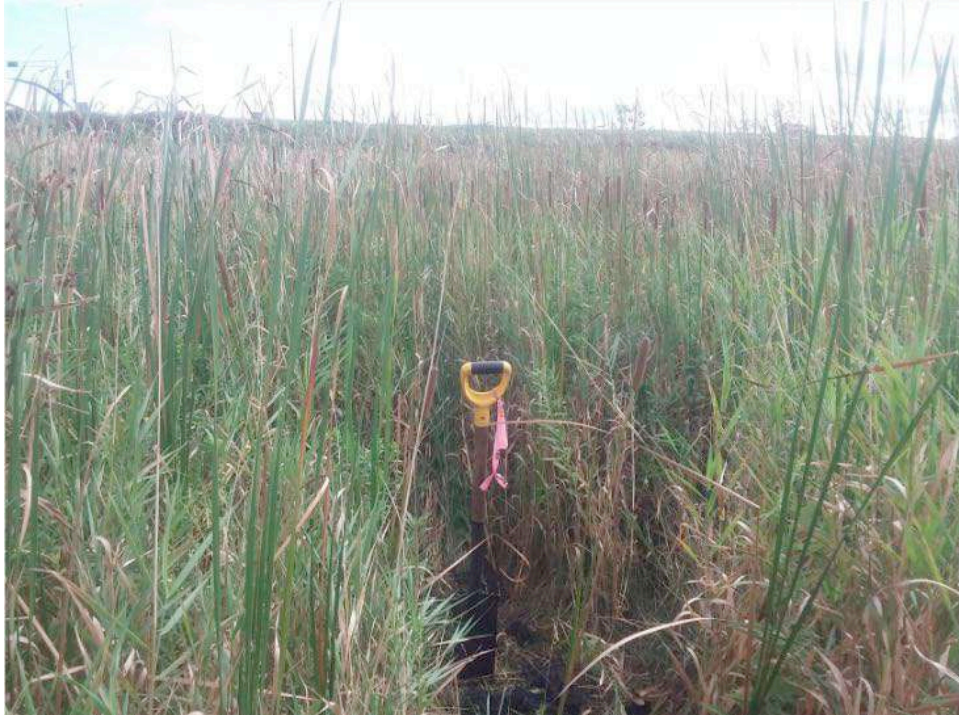
Wetland - Plot 1A

- ❖ The soil was examined in only one wetland sample plot (1A). The soil surface layer was comprised of 10 YR 2/1-colored silt loam. The subsoil (B-horizon) was comprised of 10 YR 4/1-colored silty clay loam.
- ❖ Wetland sample plot 1A showed the hydric soil indicators “Thick Dark Surface” (A12). The remaining wetland sample plots (2A & 3A) possessed standing water and vegetation dominated by FacW & Obl-rated species, therefore no soil pits were dug and the soils were assumed hydric without direct examination.
