# **Assured Wetland Delineation Report**

## **Moore Property**

Town of York, Dane County, Wisconsin August 9, 2021

Project Number: 20210467

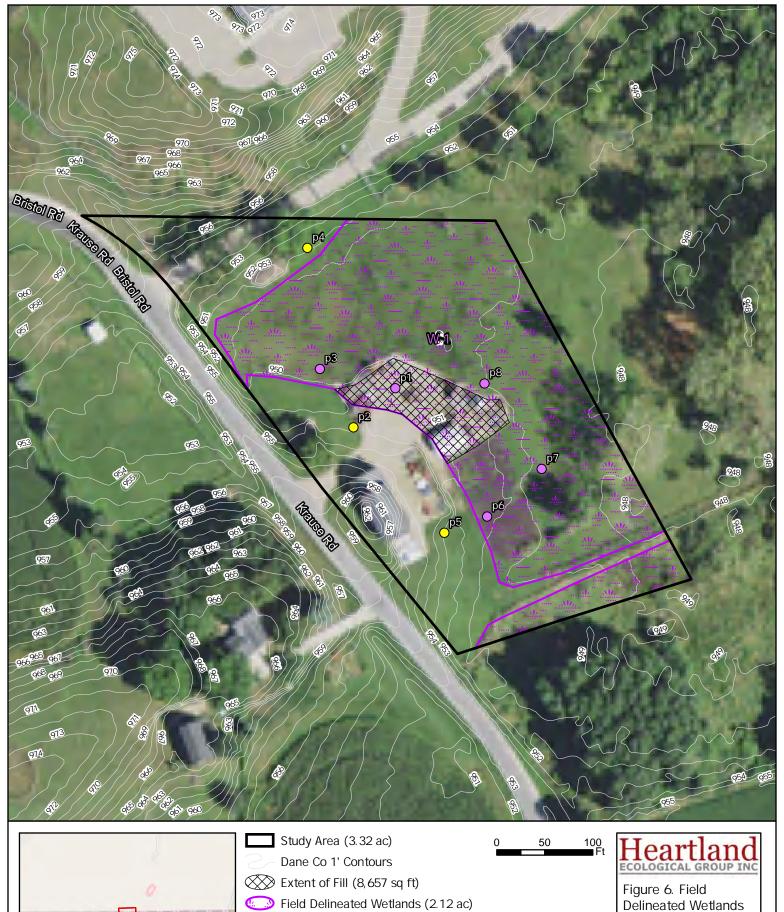
## Sample Points

One (1) wetland area totaling approximately 2.12 acres was delineated and mapped within the Study Area (Figure 6, Appendix A). This acreages includes a portion of the gravel parking lot that was likely wetland prior to its construction. Wetlands discussed in this report may be subject to federal regulation under the jurisdiction of the U.S. Army Corps of Engineers (USACE), state regulation under the jurisdiction of the WDNR, and local zoning authorities. Heartland recommends this report be submitted to local authorities, the WDNR, and USACE for final jurisdictional review and concurrence.

Wetland 1 (W-1) is a 2.12-acre wet meadow present within the north-central and eastern portions of the Study Area.

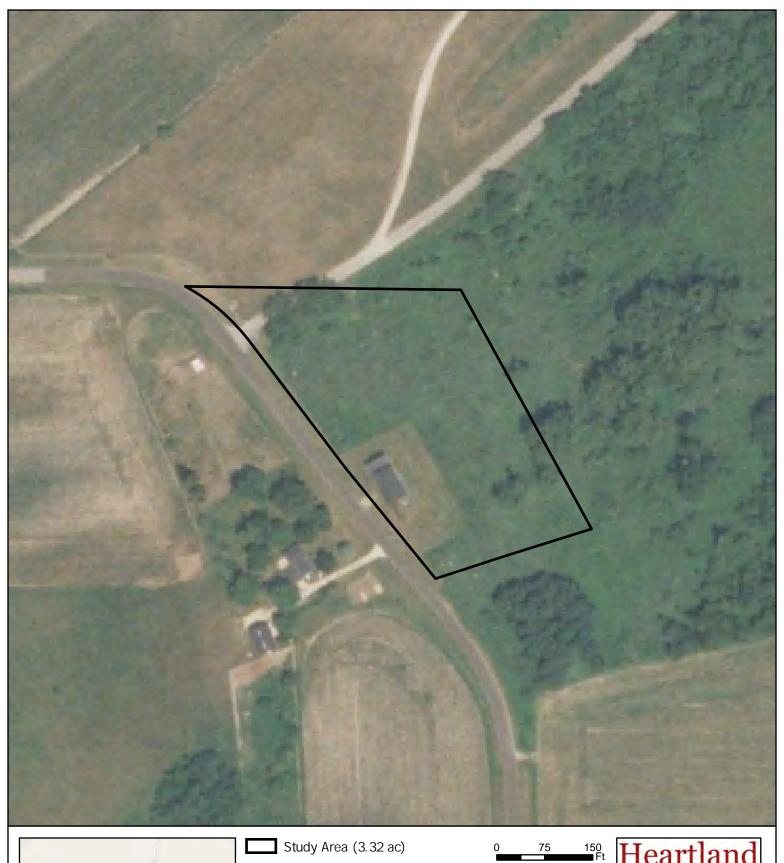
Appendix: 2004-06-22 NAIP Aerial Imagery

An area where gravel was introduced for the construction of a parking lot and shed was evaluated to determine if the gravel was placed within wetland W-1. Hydric soils were found to be present underneath the gravel, indicating that this area was wetland prior to the parking lots construction. The area of fill measures approximately 8,657 square feet and is depicted on Figure 6, Appendix A. This was consistent with wetland signatures identified on historic aerial photographs reviewed prior to the disturbance (Appendix A).

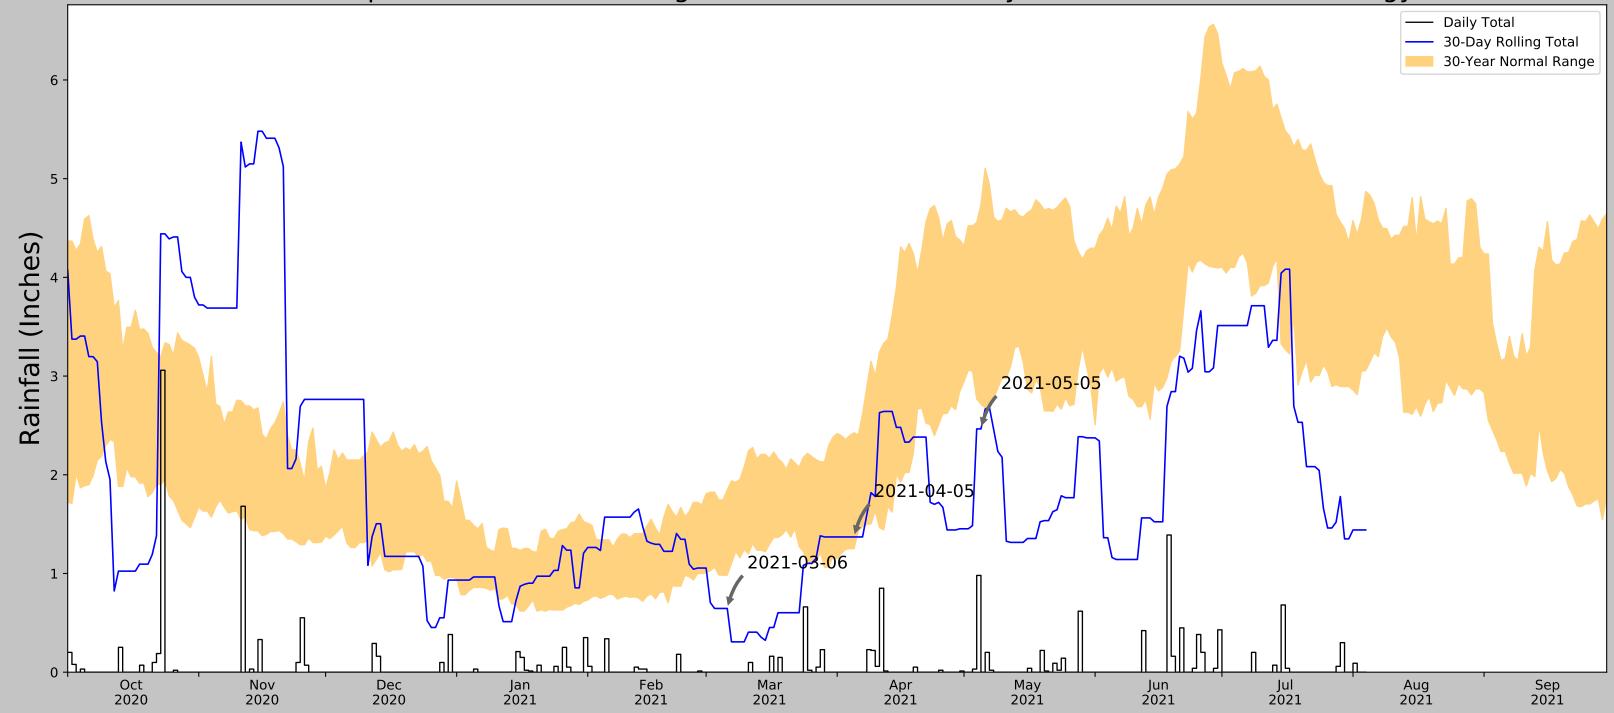
# Antecedent Precipitation vs Normal Range based on NOAA's Daily Global Historical Climatology Network

According to the WETS analysis using the previous three (3) months of precipitation data, conditions encountered at the time of the fieldwork were expected to be dry for the time of year (Appendix B). The Palmer Drought Index was checked on line and the long-term conditions at the time of the fieldwork were in the mild wetness range. Fieldwork was completed outside the dry-season based on long-term regional hydrology data utilized in the WebWIMP Climatic Water Balance web site.

Coordinates	43.282075, -89.104119
Observation Date	2021-05-05
Elevation (ft)	955.15
Drought Index (PDSI)	Mild wetness
WebWIMP H <sub>2</sub> O Balance	Dry Season

30 Days Ending	30 <sup>th</sup> %ile (in)	70 <sup>th</sup> %ile (in)	Observed (in)	Wetness Condition	Condition Value	Month Weight	Product
2021-05-05	2.714567	4.737402	2.464567	Dry	1	3	3
2021-04-05	1.251575	2.425984	1.370079	Normal	2	2	4
2021-03-06	0.98189	1.847244	0.645669	Dry	1	1	1
Result							Drier than Normal - 8
