DANE COUNTY PUBLIC LAND SURVEY MONUMENT RECORD

SECTION NUMBER: 22

TOWNSHIP 6 **NORTH, RANGE** 10 **EAST**

CORNER IDENTIFICATION NUMBER 40610220000

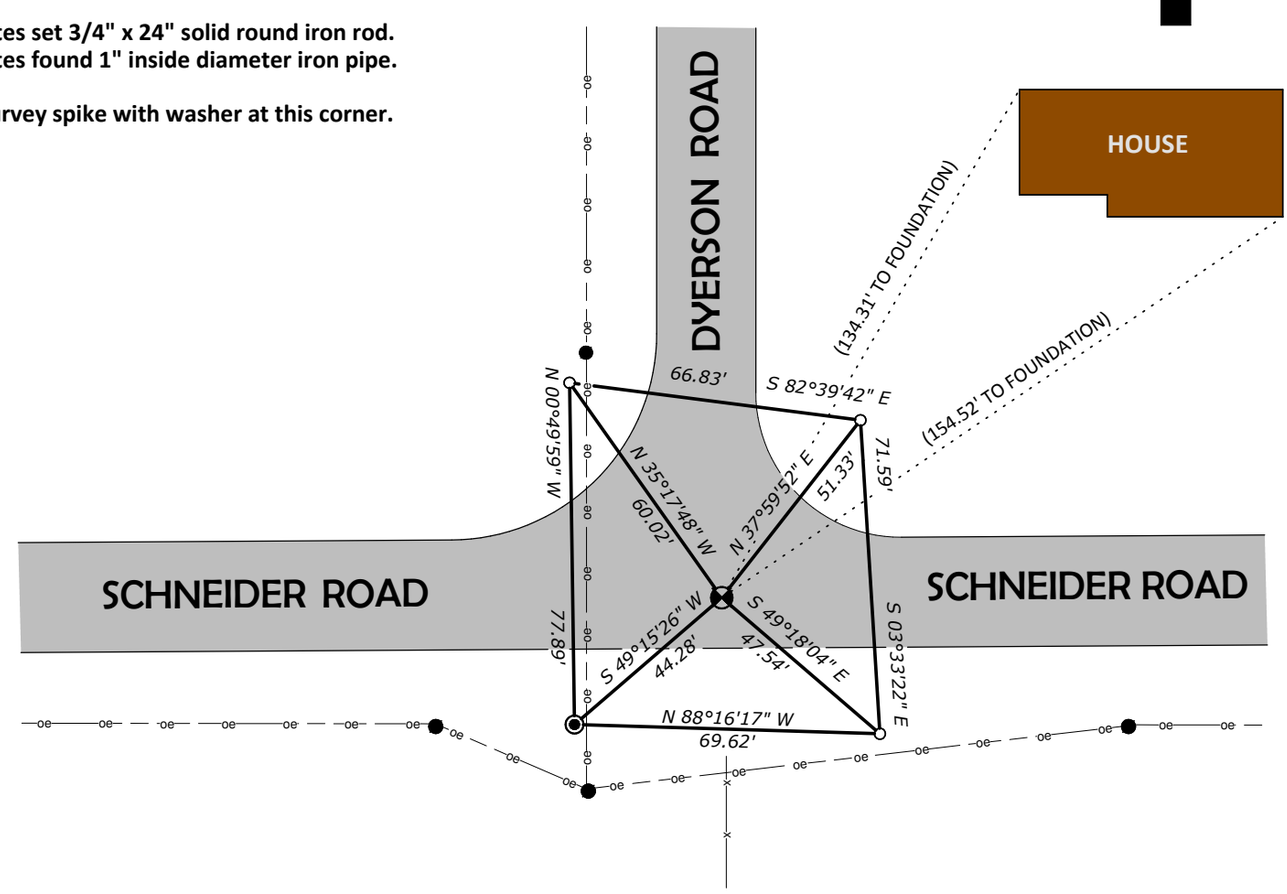
I found a deteriorated aluminum monument at this corner as per Monument Record Sheet by William Karns. I patched the pavement and set a survey spike with washer at the corner.

I set a survey spike with washer at this corner.
