# DANE COUNTY PUBLIC LAND SURVEY MONUMENT RECORD

SECTION NUMBER: 6

TOWNSHIP 6 NORTH, RANGE 10 EAST

CORNER IDENTIFICATION NUMBER 40610064040

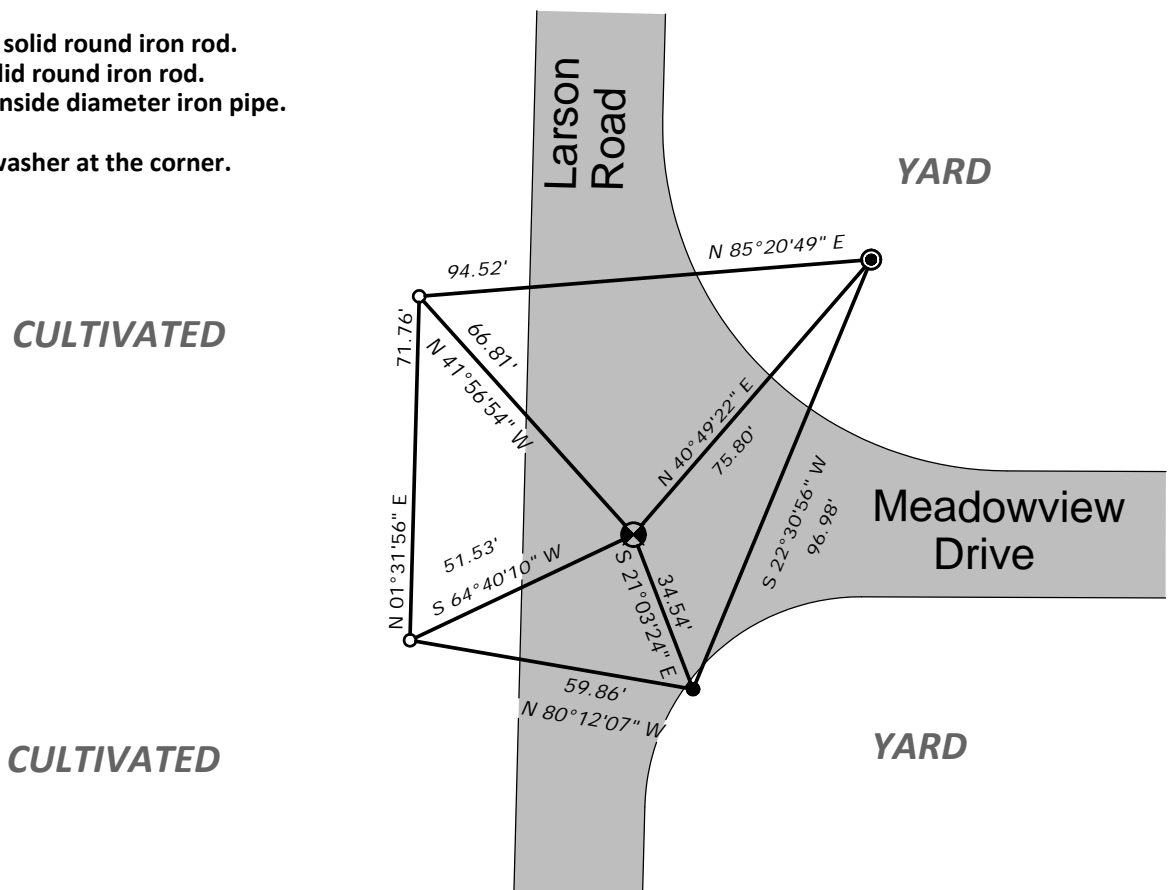
**(c) CORNER LOCATION SKETCH:** In the sketch, provide reference ties to at least 4 witness monuments of lasting durable material.

I found a concrete monument with a brass cap per Monument Record Sheet by Bruce Frudden, Glen Northrop and Richard Zach. We located the monument and a few days later the corner and water box were destroyed by paving work. After the pavement work was done, I set a survey spike with washer in place of the concrete monument with a brass cap.

Bearings are grid based on the Dane County coordinate system designed by the Wisconsin Department of Transportation. NAD83 (2011)

Scale: 1" = 40'

- Denotes set 3/4" x 24" solid round iron rod.
- Denotes found 5/8" solid round iron rod.
- ⊙ Denotes found 1 1/4" inside diameter iron pipe.

I set a survey spike with washer at the corner.
