# DANE COUNTY PUBLIC LAND SURVEY MONUMENT RECORD

SECTION NUMBER: 11  
 TOWNSHIP 6 NORTH, RANGE 10 EAST  
 DANE COUNTY COORDINATES  
 NORTHING: 454977.53'  
 EASTING: 852362.68'  
 HORIZONTAL DATUM & ADJUSTMENT: NAD 83 (2011)  
 ORTHOMETRIC HEIGHT: 853.10' VERTICAL DATUM: NAVD 88

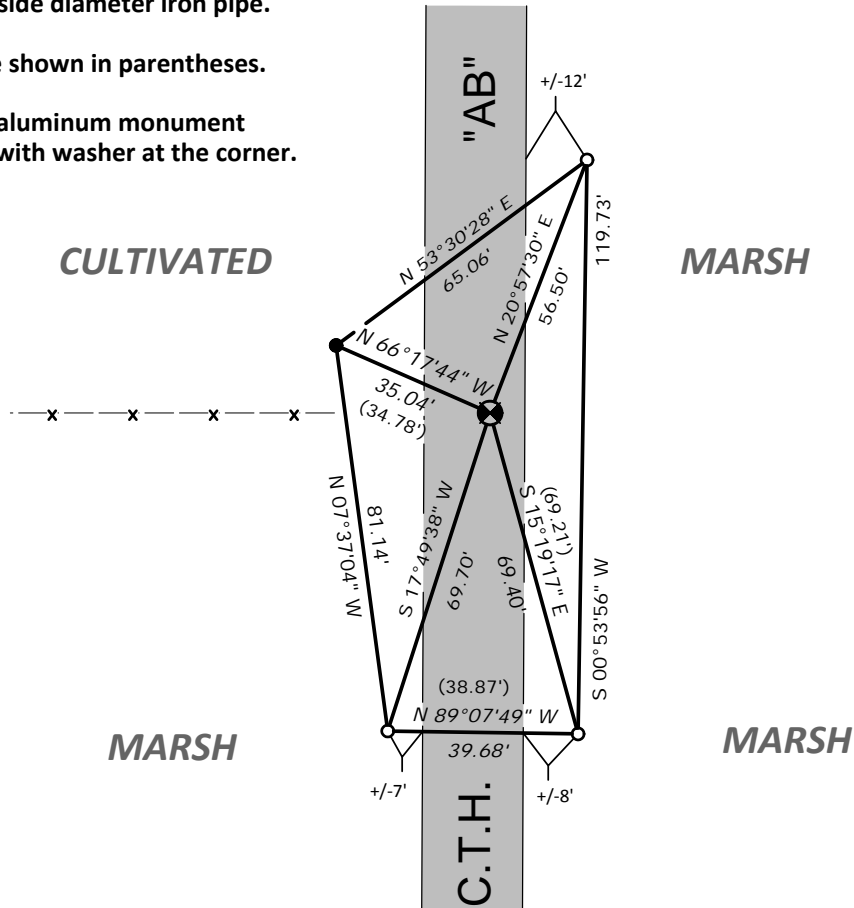
Bearings are grid based on the Dane County coordinate system designed by the Wisconsin Department of Transportation. NAD83 (2011)

Scale: 1" = 40'

- Denotes found 3/4" solid round iron rod with plastic cap.
- Denotes found 1" inside diameter iron pipe.

Recorded distances are shown in parentheses.

I found a deteriorated aluminum monument and set a survey spike with washer at the corner.

I found a broken aluminum monument at this corner as per Monument Reference Sheet by William Karns. I set a Survey Spike with a washer in place of the aluminum monument.
