# DANE COUNTY PUBLIC LAND SURVEY MONUMENT RECORD

SECTION NUMBER: 21

TOWNSHIP 6 NORTH, RANGE 10 EAST

CORNER IDENTIFICATION NUMBER 40610210020

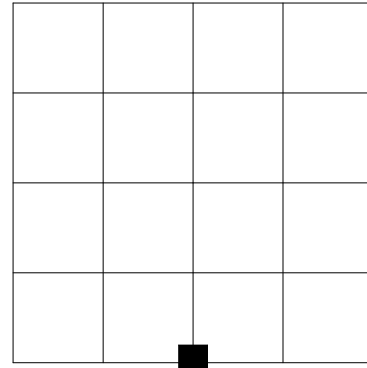
**MARK CORNER LOCATION**

I found a deteriorated aluminum monument at this corner as per Monument Record Sheet by William Karns. I patched the pavement and set a survey spike with washer at the corner.

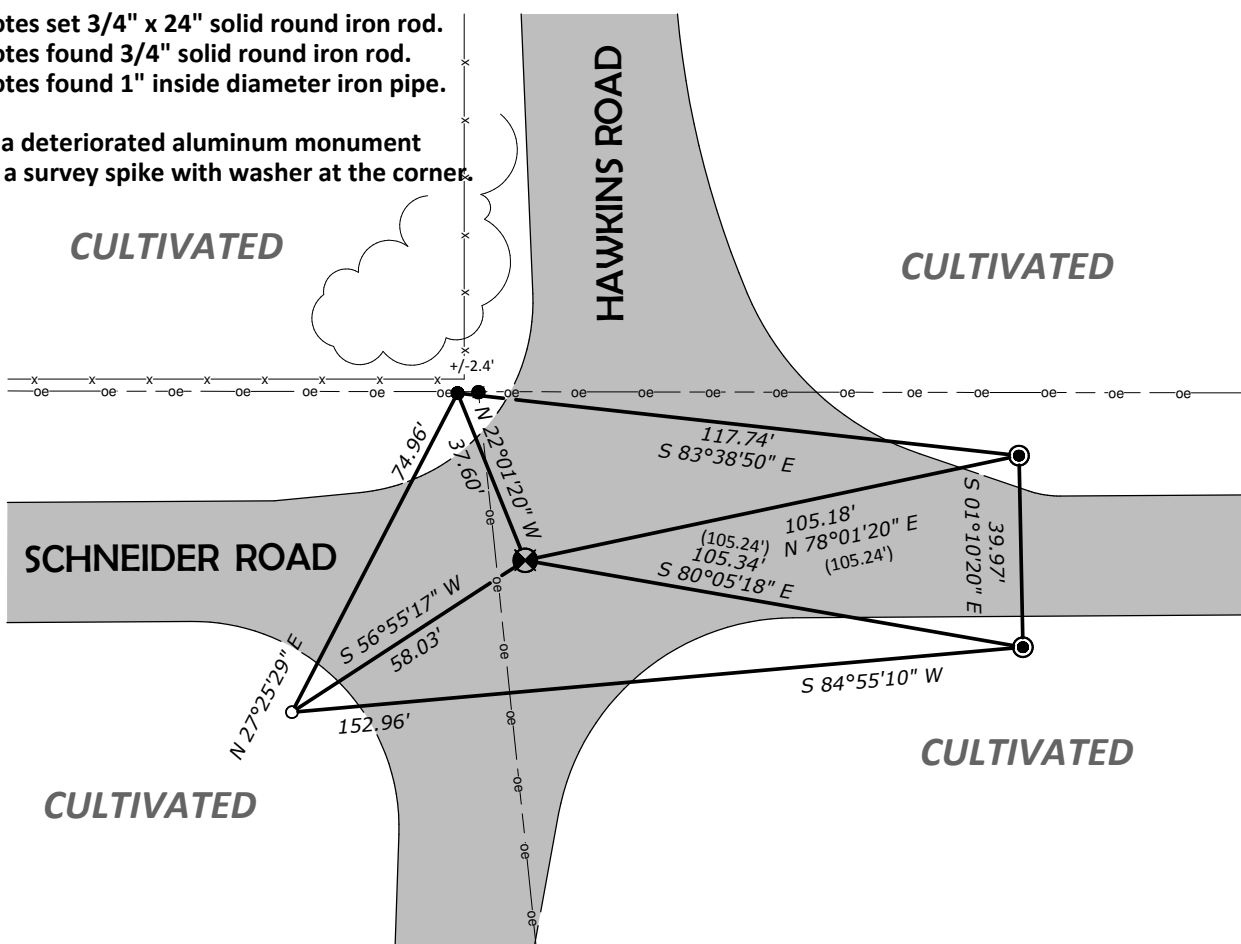
**(c) CORNER LOCATION SKETCH:** In the sketch, provide reference ties to at least 4 witness monuments of lasting durable material.

Bearings are grid based on the Dane County coordinate system designed by the Wisconsin Department of Transportation. NAD83 (2011)

Scale: 1" = 40'

I found a deteriorated aluminum monument and set a survey spike with washer at the corner.
