DANE COUNTY PUBLIC LAND SURVEY MONUMENT RECORD

SECTION NUMBER: 31
 TOWNSHIP 6 NORTH, RANGE 10 EAST
 DANE COUNTY COORDINATES
 NORTHING: 433318.69'
 EASTING: 830791.51'
 HORIZONTAL DATUM & ADJUSTMENT: NAD 83 (2011)
 ORTHOMETRIC HEIGHT: 933.35' VERTICAL DATUM: NAVD 88

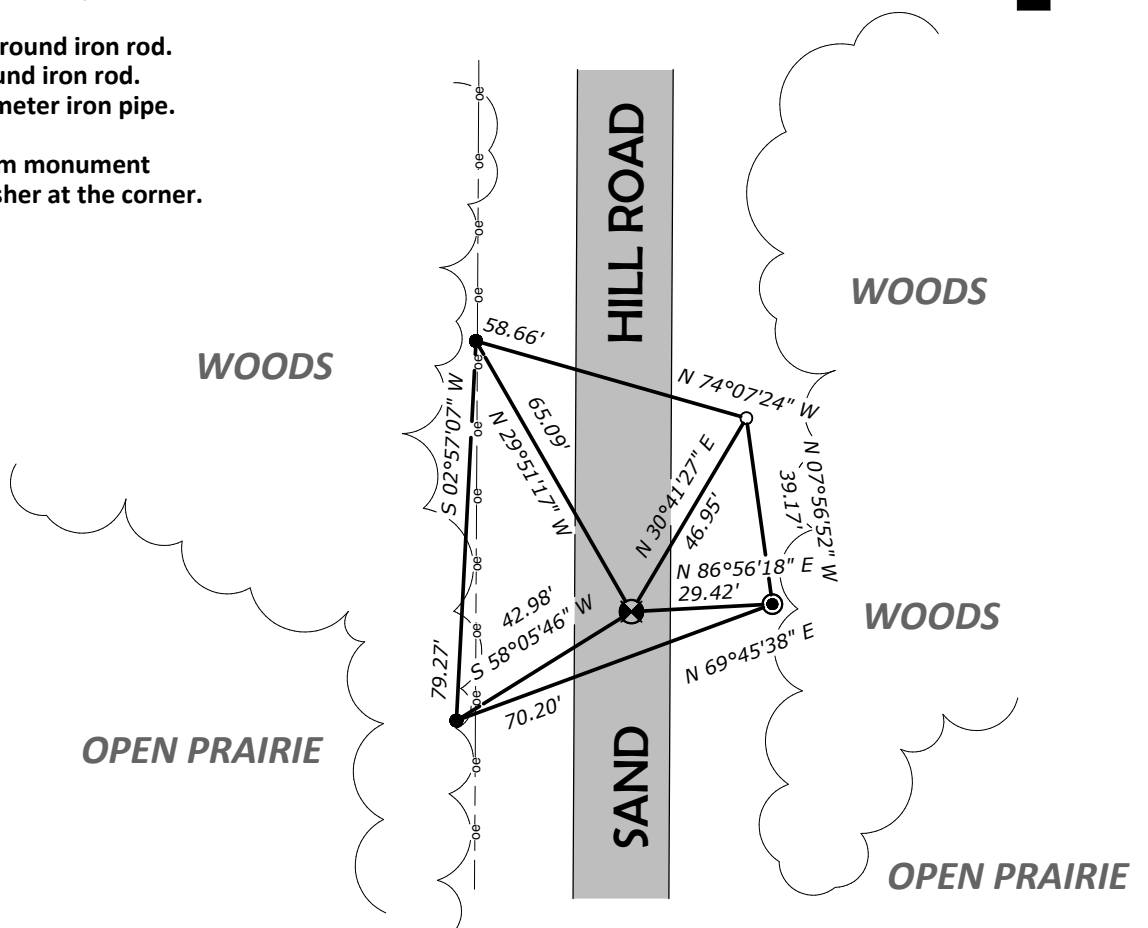
(c) CORNER LOCATION SKETCH: In the sketch, provide reference ties to at least 4 witness monuments of lasting durable material.

Bearings are grid based on the Dane County coordinate system designed by the Wisconsin Department of Transportation. NAD83 (2011)

Scale: 1" = 40'

I found a deteriorated aluminum monument and set a survey spike with washer at the corner.

I found a deteriorated aluminum monument at this corner as per Monument Record Sheet by Gregory Held. I patched the pavement and set a survey spike with washer at the corner.
