DANE COUNTY PUBLIC LAND SURVEY MONUMENT RECORD

SECTION NUMBER: 31
 TOWNSHIP 7 NORTH, RANGE 10 EAST
 DANE COUNTY COORDINATES
 NORTHING: 462240.90'
 EASTING: 831496.51'
 HORIZONTAL DATUM & ADJUSTMENT: NAD 83 (2011)
 ORTHOMETRIC HEIGHT: 873.07' (To Spike) VERTICAL DATUM: NAVD 88

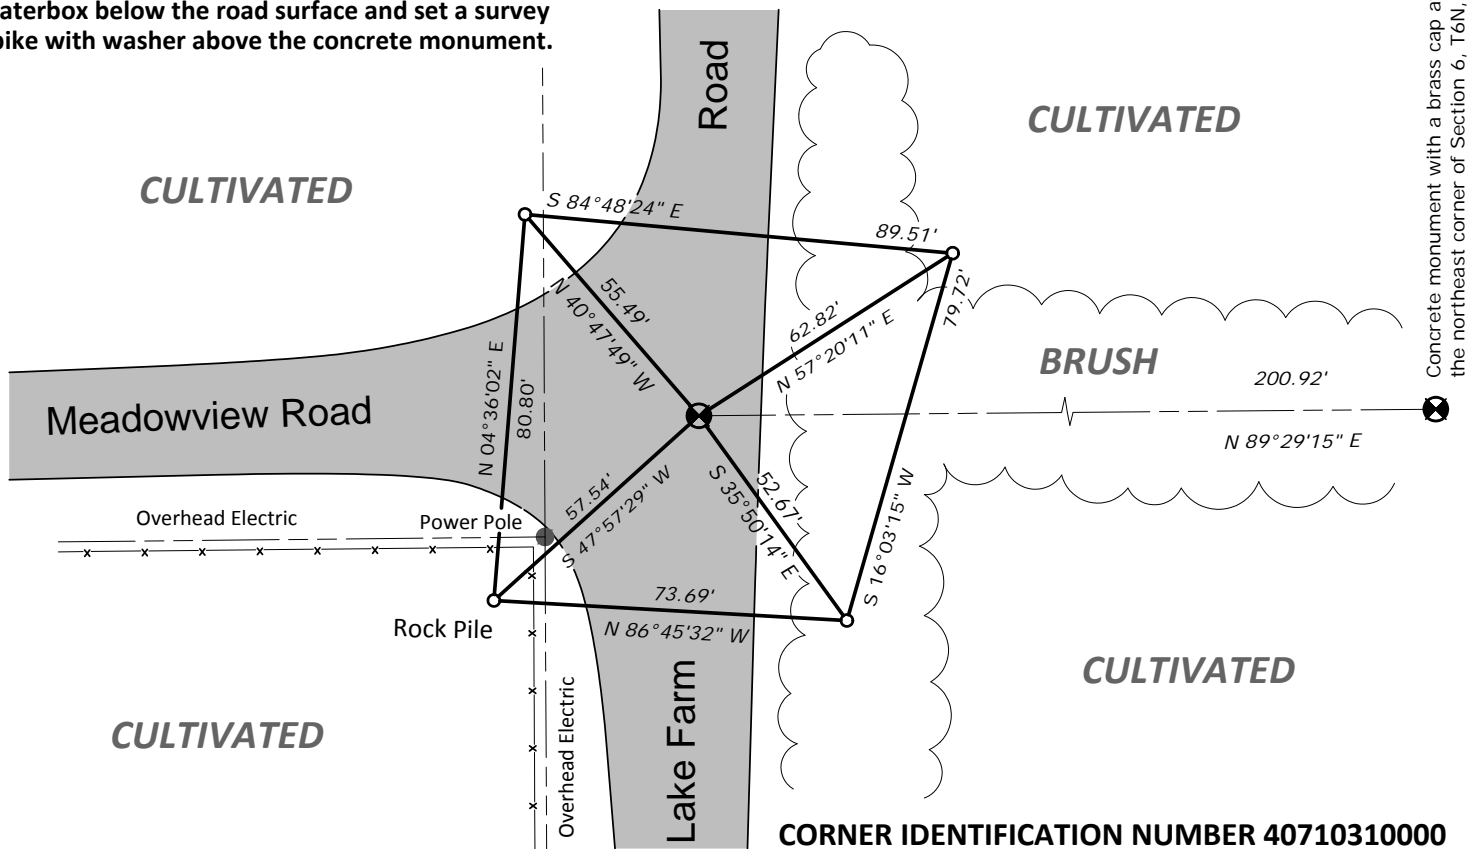
(c) CORNER LOCATION SKETCH: In the sketch, provide reference ties to at least 4 witness monuments of lasting durable material.

I found a concrete monument with a brass cap in an 8" water valve manhole 6" below the surface at the intersection of Meadowview Road and Lake Farm Road as per Monument Reference Sheet by Bruce Frudden. I set a survey spike with washer at the surface above the concrete monument with a brass cap.

Bearings are grid based on the Dane County coordinate system designed by the Wisconsin Department of Transportation. NAD83 (2011)

Scale: 1" = 40'

○ Denotes set 3/4" x 24" solid round iron rod.

I found a concrete monument with a brass cap in a waterbox below the road surface and set a survey spike with washer above the concrete monument.
